CORRECTIVE ACTION PLAN

The Lodge at Hover Crossing

2127 18th Avenue
Longmont, CO 80501

February 22, 2022
Amended January 13, 2023

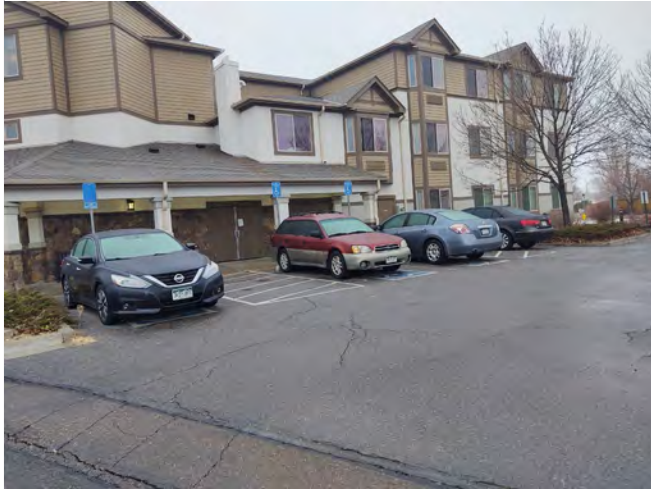
4.6.1, 4.1.1(5)(a) and 4.1.1(5)(d)(i)	Parking - Minimum Number and Accessible Sites	(1) Accessible parking space for each accessible dwelling unit plus 2% of the provided spaces for visitors. [(3) Accessible parking spaces for each accessible dwelling unit plus (2) accessible parking spaces for 39 visitor parking spaces = 5 total required.]	(3) accessible parking spaces have been provided on site.	L #1	(2) additional accessible parking spaces with access aisles are to be provided closest to the accessible entrance.	The estimated material cost to rework and restripe approximately 500 square feet of the asphalt parking lot is \$900.00. The labor to rework the asphalt parking lot is approximately 10 hours for a labor cost of \$700.00. Therefore, the material and labor estimated construction cost would be \$1,600.00.	\$1,600.00	\$1,600.00

Photo L1 – 3 Accessible parking spaces with access aisles.

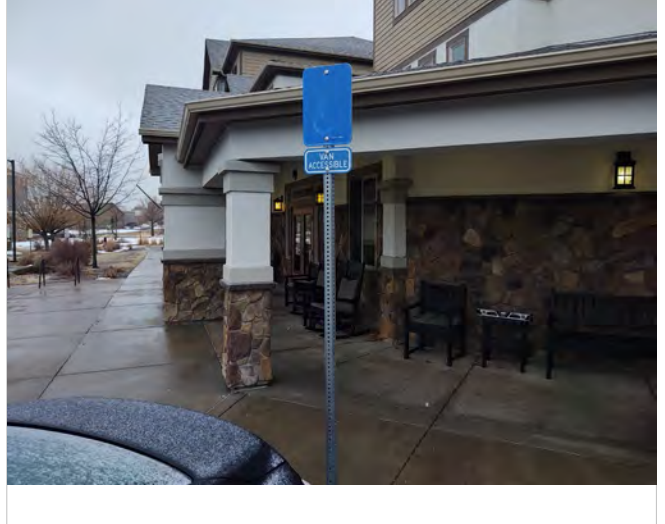
4.6.4 and 4.1.1(7)(a)	Parking - Signage and Accessible Sites	Accessible parking spaces shall be designated as reserved by a sign.	One of the signs in front of the existing accessible parking spaces is not compliant and is to be replaced.	L #2	(2) new accessible parking signs and (1) replacement sign are to be installed in front of the new accessible parking spaces.	The estimated cost of the 2 new posts is \$60.00. The estimated cost of the 3 new accessible signs is \$90.00. The labor to install the 2 new posts and install the new signs is approximately 3 hours for a labor cost of \$210.00. Therefore, the parts and labor estimated construction cost would be \$360.00.	\$360.00	\$360.00

Photo L2 – Faded accessible parking signage

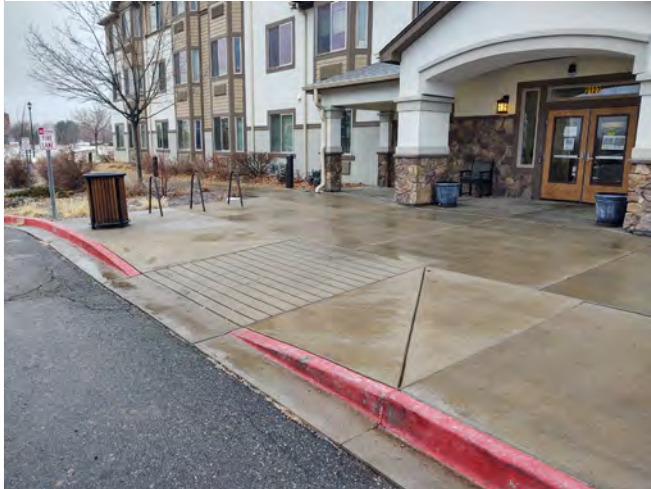
4.1.1(7)(G) and 4.30.5	Entrance Signage	If not all common use entrances are accessible, the entrances and the non-accessible entrances shall be identified.	The front and rear entrances to the housing units are accessible but the (2) side entrances are not accessible.	L #3, L #4, L #5, & L #6	Signage indicating accessibility are to be installed at the front and rear entrances. Signage indicating non-accessible are to be installed adjacent to the non-accessible side entrances.	The estimated cost of the 2 new accessible signs is \$60.00. The estimated cost of the 2 new signs indicating non-accessibility with posts is \$120.00. The labor to install the 4 new signs is approximately 4 hours for a labor cost of \$280.00. Therefore, the parts and labor estimated construction cost would be \$460.00.	\$460.00	\$460.00						
Interior and Common Spaces

Photo L3 – Front accessible entrance without signage.

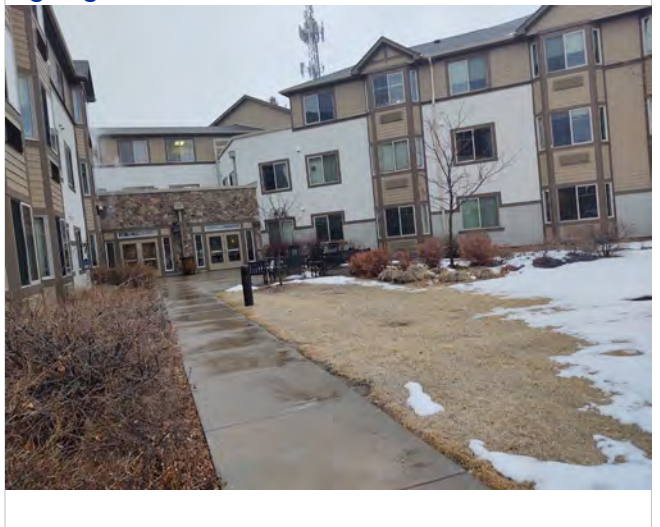
Photo L4 – Rear accessible entrance without signage.

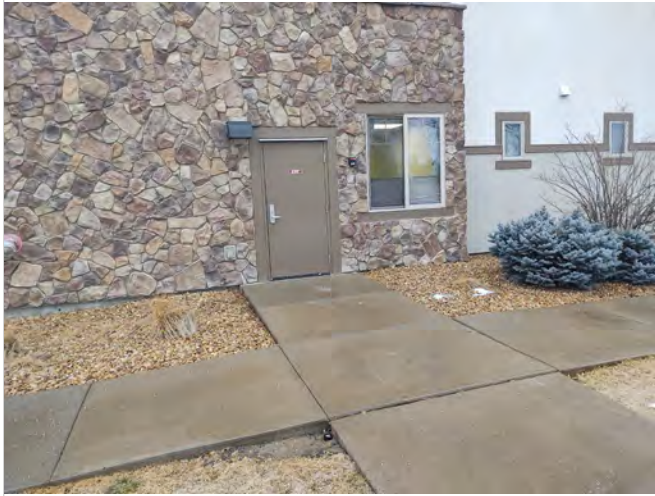
Photo L5 – Non-accessible side entrance door.

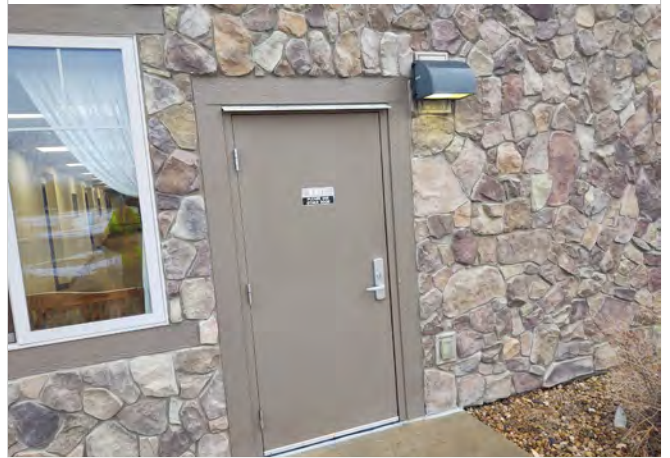
Photo L6 – Non-accessible side entrance door.

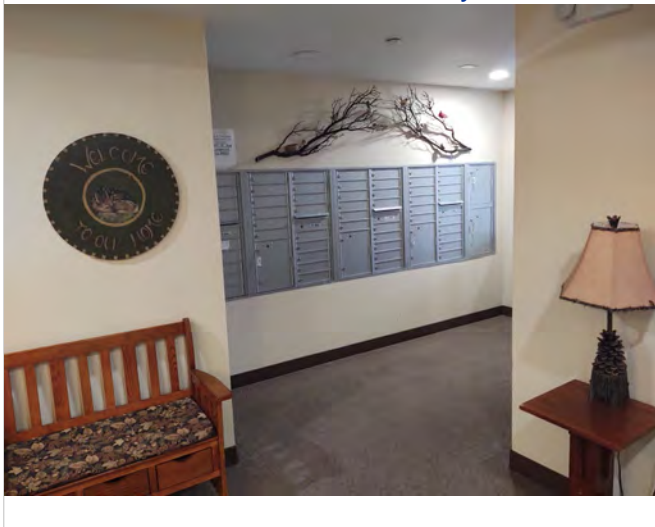
4.2.6	Mailboxes - Side Approach	The maximum high side reach allowed is 54" above the floor.	The height to the top of the mail boxes is 65 1/2"	L #7 & L #8	Residents with disabilities can request the U.S. Postal Service to accommodate their disability by assigning them a mailbox on the bottom row.	No cost	\$0.00	\$0.00

Photo L7 – Mailbox bank in lobby.

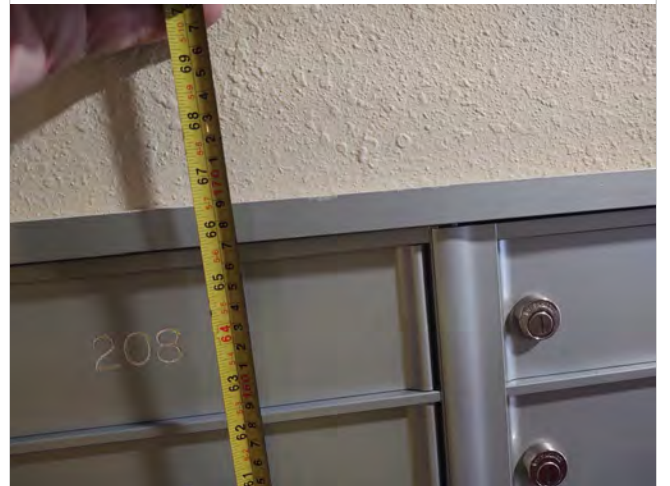
Photo L8 – Measured height to top of mailbox bank at 65 1/2”.

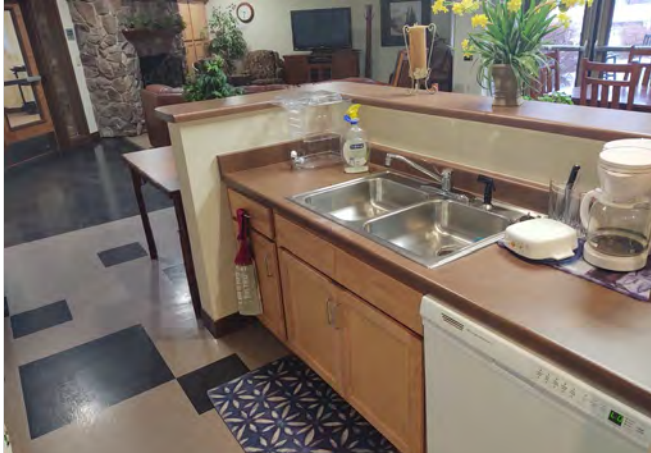
4.34.6.5(5)	Community Kitchen - Sink	The base cabinet, if provided, shall be removable and the finished floor shall extend under the counter to the wall	The sink has a permanent base cabinet.	L #9	The base cabinet is to be removed and the finished floor constructed to the back wall.	The estimated material cost to finish the bottom and edges of the sink and extend the finish flooring to the wall is \$125.00. The labor to remove the existing cabinet and install new side cabinets and flooring is 8 hours for a labor cost of \$560.00. Therefore, the material and labor estimated construction cost would be \$685.00.	\$685.00	\$685.00

Photo L9 – Community Room – Kitchen sink with permanent base cabinet.

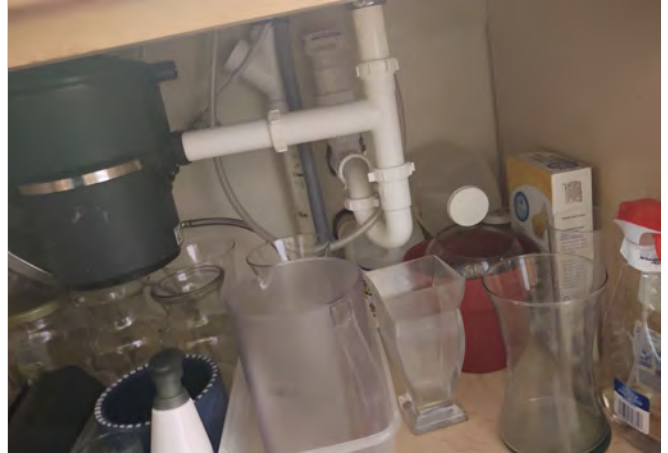
4.34.6.5(6)	Community Kitchen - Sink	There shall be no sharp or abrasive surfaces under sinks. Hot water and drain pipes under sinks shall be insulated or otherwise covered.	The hot water and drain piping are exposed.	L #10	Install insulated covering over exposed piping.	The estimated material cost of the insulation covering is \$25.00. The labor to install the insulated covering is 1/2 hour for a labor cost of \$35.00. Therefore, the material and labor estimated construction cost would be \$60.00.	\$60.00	\$60.00

Photo L10 – Community Room – Exposed piping beneath kitchen sink.

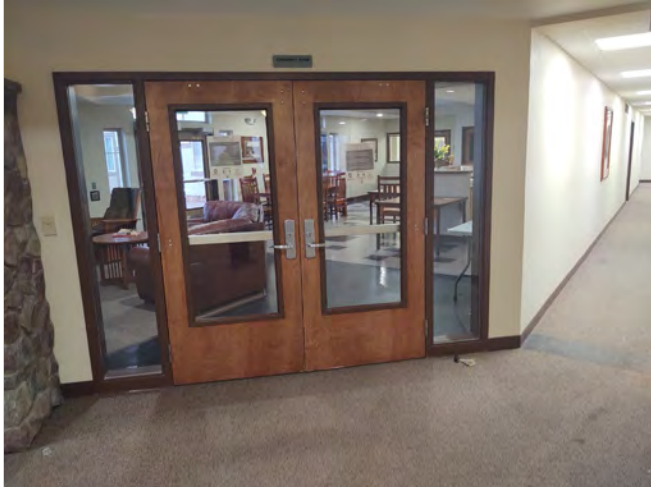
4.1.1(7) and 4.30.6	Sign Mounting Location and Height	Interior signage shall be located alongside the door on the latch side and shall be mounted at a height of between 54" and 66" above the finished floor.	The signage for the Community Room and for the Library are located over the doorway	L #11 & L #12,	Signage in conformance with Section 4.30 Signage is to be provided adjacent to the Community Room and Library doorways	The estimated cost of the 2 new identification signs is \$60.00. The labor to install the 2 new signs is approximately 1 hour for a labor cost of \$70.00. Therefore, the parts and labor estimated construction cost would be \$150.00.	\$150.00	\$150.00								
Accessible Dwelling Unit; Guest Room #104; 1-Bedroom

Photo L11 – Signage for Community Room located over the doorway.

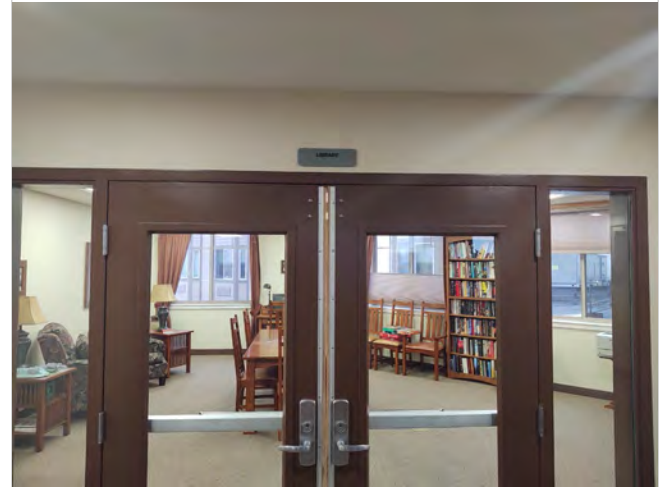
Photo L12 – Signage for Library Room located over the doorway.

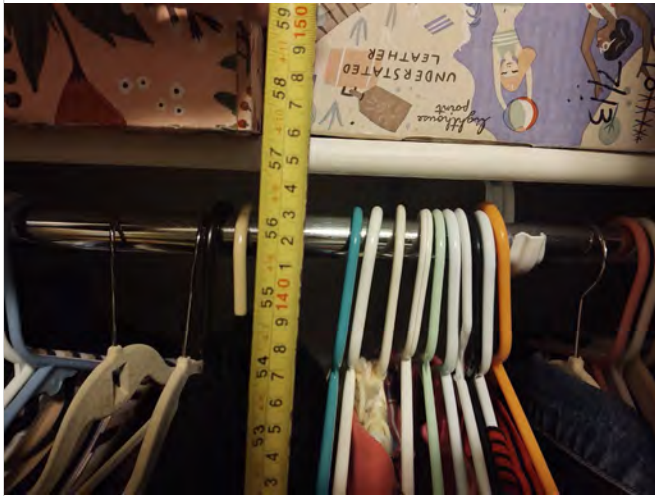
4.2.5.3 and 4.2.6	Storage - Height	Clothes rods shall be a maximum of 54" from the floor	The measured dimension to the top of the clothes rod was 56".	L #13	The existing clothes rod is to be lowered to not more than 54" above the floor.	The labor to relocate the clothes rod is approximately 1 hour for a labor cost of \$70.00.	\$70.00	\$70.00

Photo L13 – Dwelling Unit #104 – Measured height to top of clothes rod at 56”.

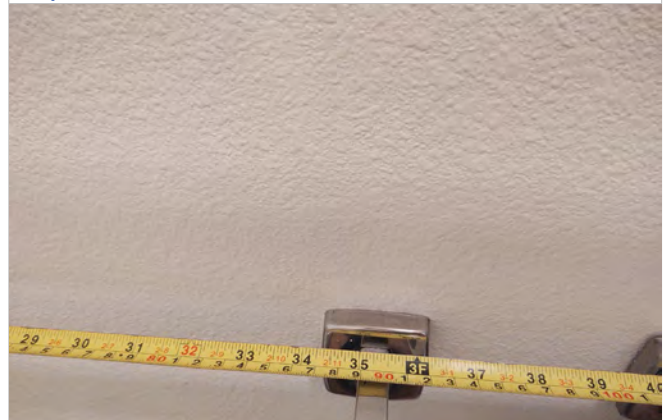
4.34.5.2(4) and Fig. 47(b)	Water Closets - Dispensers	Starting at the edge farthest from the back wall, the toilet paper dispenser is no more than 36" from the back wall.	The far reach of the toilet paper dispenser is approximately 41" from the back wall.	L #14	Relocate the toilet paper dispenser to be within 36" from back wall.	The labor to remove and relocate the existing toilet paper dispenser is approximately 2 hours for a labor cost of \$140.00.	\$140.00	\$140.00

Photo L14 – Dwelling Unit #104 – Measured dimension of 36” to front edge of toilet paper dispenser.

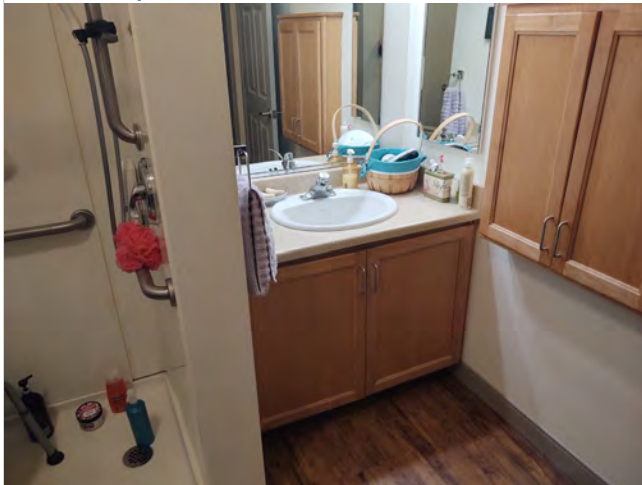
4.34.6.5(5)	Bathroom Sink	The base cabinet, if provided, shall be removable and the finished floor shall extend under the counter to the wall	The sink has a permanent base cabinet.	L #15	The base cabinet is to be removed and the finished floor constructed to the back wall.	The estimated material cost to finish the bottom and edges of the sink and extend the finish flooring to the wall is \$125.00. The labor to remove the existing base cabinet and install new cabinet siding and flooring is 8 hours for a labor cost of \$560.00. Therefore, the material and labor estimated construction cost would be \$685.00.	\$685.00	\$685.00

Photo L15 – Dwelling Unit #104 – Bathroom sink with permanent base cabinet.

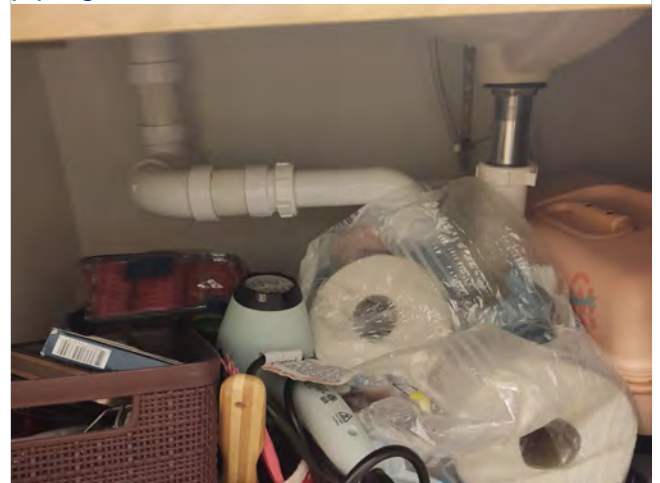
4.34.6.5(8)	Bathroom Sink	There shall be no sharp or abrasive surfaces under sinks. Hot water and drain pipes under sinks shall be insulated or otherwise covered.	The hot water and drain piping are exposed.	L #16	Install insulated covering over exposed piping.	The estimated material cost of the insulation covering is \$25.00. The labor to install the insulated covering is 1/2 hour for a labor cost of \$35.00. Therefore, the material and labor estimated construction cost would be \$60.00.	\$60.00	\$60.00

Photo L16 – Dwelling Unit #104 – Exposed piping beneath bathroom sink.

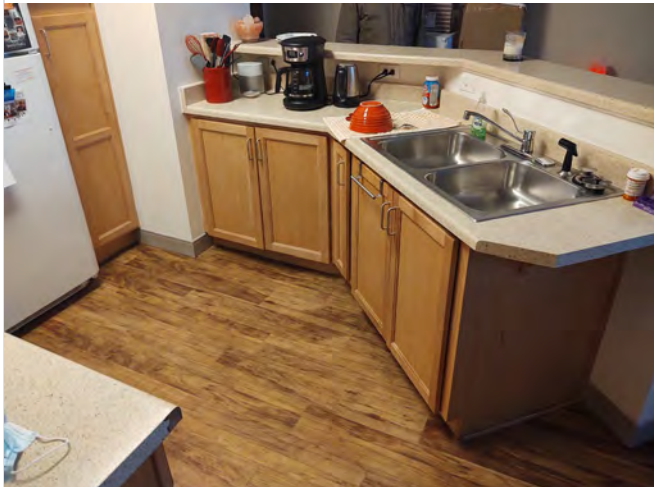
4.34.6.5(5)	Kitchen Sink	The base cabinet, if provided, shall be removable and the finished floor shall extend under the counter to the wall	The sink has a permanent base cabinet.	L #17	The base cabinet is to be removed and the finished floor constructed to the back wall.	The estimated material cost to finish the bottom and edges of the sink and extend the finish flooring to the wall is \$125.00. The labor to remove the existing base cabinet and install new cabinet siding and flooring is 8 hours for a labor cost of \$560.00. Therefore, the material and labor estimated construction cost would be \$685.00.	\$685.00	\$685.00

Photo L17 – Dwelling Unit #104 - Kitchen sink with permanent base cabinet.

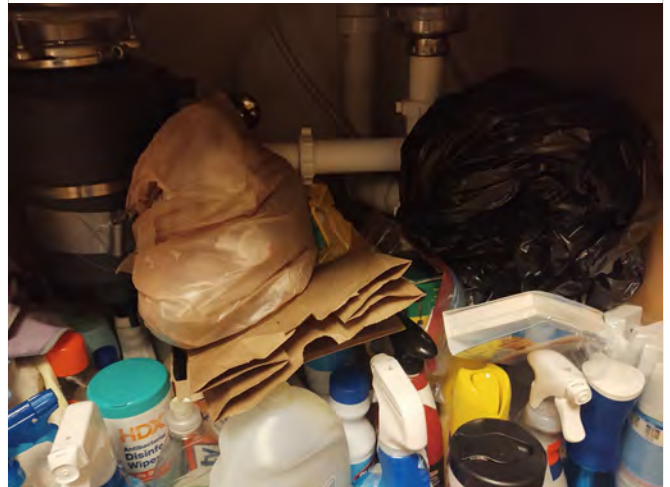
4.34.6.5(8)	Kitchen Sink	There shall be no sharp or abrasive surfaces under sinks. Hot water and drain pipes under sinks shall be insulated or otherwise covered.	The hot water and drain piping are exposed.	L #18	Install insulated covering over exposed piping.	The estimated material cost of the insulation covering is \$25.00. The labor to install the insulated covering is 1/2 hour for a labor cost of \$35.00. Therefore, the material and labor estimated construction cost would be \$60.00.	\$60.00	\$60.00								
Accessible Dwelling Unit; Guest Room #106; 1-Bedroom

Photo L18 – Dwelling Unit #104 - Exposed piping beneath kitchen sink.

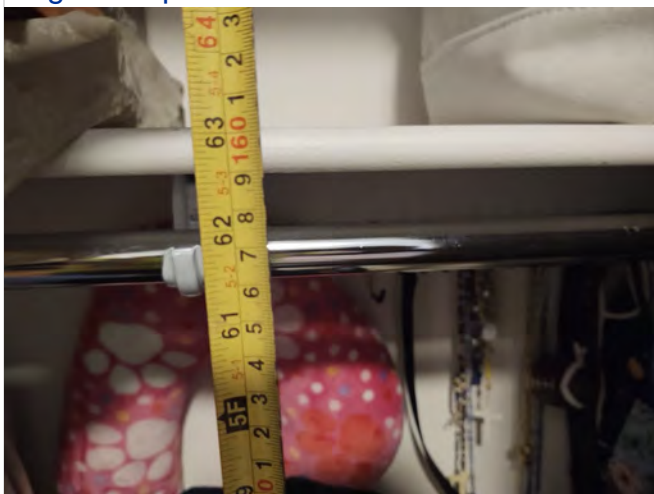
4.2.5.3 and 4.2.6	Storage - Height	Clothes rods shall be a maximum of 54" from the floor	The measured dimension to the top of the clothes rod was 62".	L #19	The existing clothes rod is to be lowered to not more than 54" above the floor.	The labor to relocate the clothes rod is approximately 1 hour for a labor cost of \$70.00.	\$70.00	\$70.00

Photo L19 – Dwelling Unit #106 - Measured height to top of clothes rod at 62”.

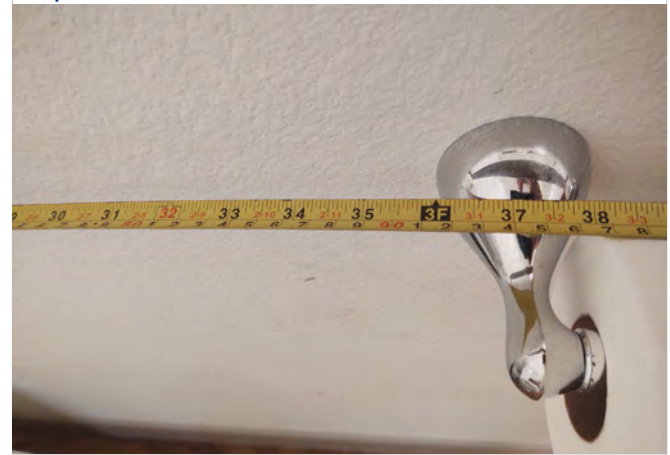
4.34.5.2(4) and Fig. 47(b)	Water Closets - Dispensers	Starting at the edge farthest from the back wall, the toilet paper dispenser is no more than 36" from the back wall.	The far reach of the toilet paper dispenser is approximately 43" from the back wall.	L #20	Relocate the toilet paper dispenser to be within 36" from back wall.	The labor to remove and relocate the existing toilet paper dispenser is approximately 2 hours for a labor cost of \$140.00.	\$140.00	\$140.00

Photo L20 – Dwelling Unit #106 - Measured dimension of 37” to front edge of toilet paper dispenser.

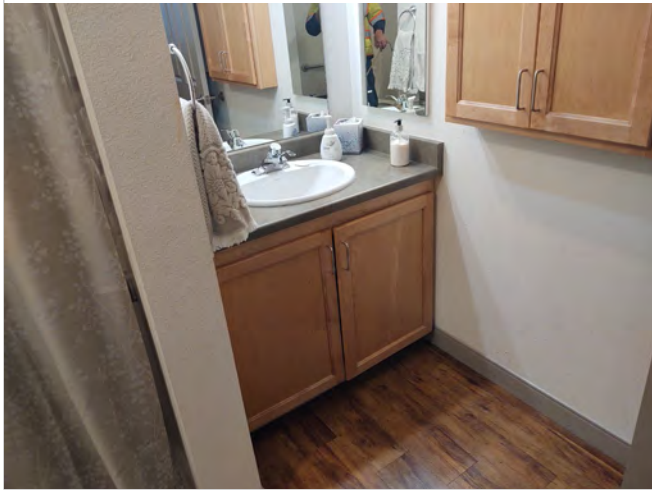
4.34.6.5(5)	Bathroom Sink	The base cabinet, if provided, shall be removable and the finished floor shall extend under the counter to the wall	The sink has a permanent base cabinet.	L #21	The base cabinet is to be removed and the finished floor constructed to the back wall.	The estimated material cost to finish the bottom and edges of the sink and extend the finish flooring to the wall is \$125.00. The labor to remove the existing base cabinet and install new cabinet siding and flooring is 8 hours for a labor cost of \$560.00. Therefore, the material and labor estimated construction cost would be \$685.00.	\$685.00		\$685.00

Photo L21 – Dwelling Unit #106 - Bathroom sink with permanent base cabinet.

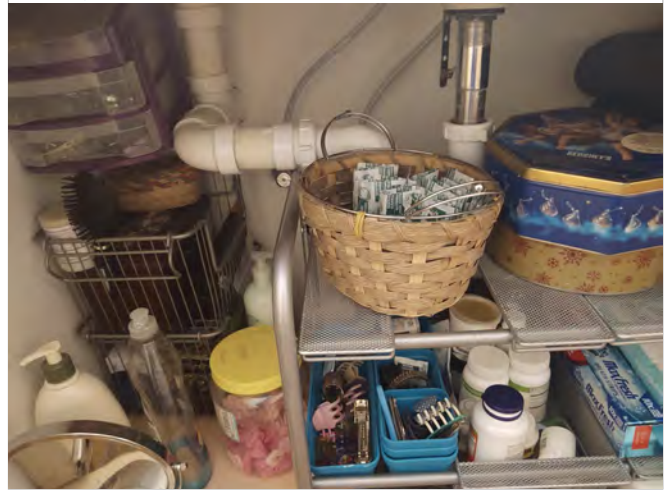
4.34.6.5(8)	Bathroom Sink	There shall be no sharp or abrasive surfaces under sinks. Hot water and drain pipes under sinks shall be insulated or otherwise covered.	The hot water and drain piping are exposed.	L #22	Install insulated covering over exposed piping.	The estimated material cost of the insulation covering is \$25.00. The labor to install the insulated covering is 1/2 hour for a labor cost of \$35.00. Therefore, the material and labor estimated construction cost would be \$60.00.	\$60.00	\$60.00

Photo L22 – Dwelling Unit #106 - Exposed piping beneath bathroom sink.

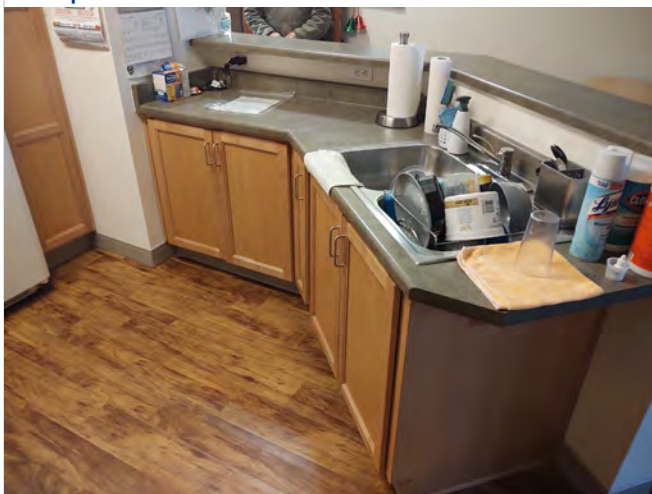
4.34.6.5(5)	Kitchen Sink	The base cabinet, if provided, shall be removable and the finished floor shall extend under the counter to the wall	The sink has a permanent base cabinet.	H #23	The base cabinet is to be removed and the finished floor constructed to the back wall.	The estimated material cost to finish the bottom and edges of the sink and extend the finish flooring to the wall is \$125.00. The labor to remove the existing base cabinet and install new cabinet siding and flooring is 8 hours for a labor cost of \$560.00. Therefore, the material and labor estimated construction cost would be \$685.00.	\$685.00		\$685.00

Photo L23 – Dwelling Unit #106 - Kitchen sink with permanent base cabinet

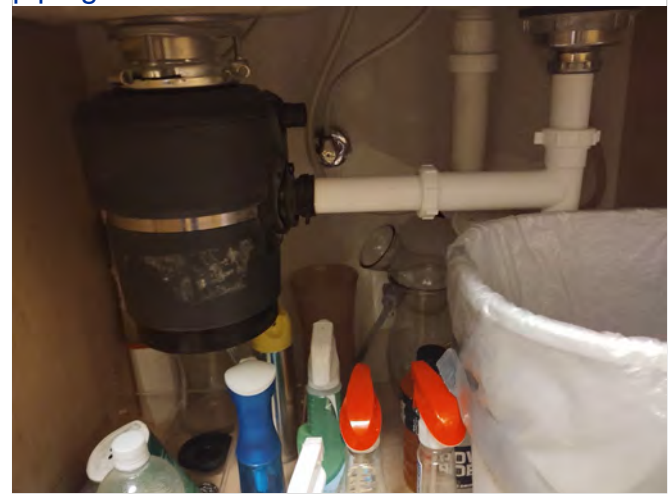
4.34.6.5(8)	Kitchen Sink	There shall be no sharp or abrasive surfaces under sinks. Hot water and drain pipes under sinks shall be insulated or otherwise covered.	The hot water and drain piping are exposed.	L #24	Install insulated covering over exposed piping.	The estimated material cost of the insulation covering is \$25.00. The labor to install the insulated covering is 1/2 hour for a labor cost of \$35.00. Therefore, the material and labor estimated construction cost would be \$60.00.	\$60.00	\$60.00								
24 C.F.R. §§ 8.22 & 8.23																
	Dwelling Units for persons with hearing or visual Impairment.	2% of 50 units = 1 unit	No dwelling units for persons with hearing or vision impairment have been designated.		(1) Dwelling unit should be provided for persons with hearing or vision impairment.	Estimated cost to renovate (1) existing dwelling unit to be accessible for persons with hearing or vision impairment is \$5,000.00 per unit.	\$5,000.00				\$5,000.00

Photo L24 – Dwelling Unit #106 - Exposed piping beneath kitchen sink.
