## CORRECTIVE ACTION PLAN

# Fall River Apartments

321 Homestead Parkway  
Longmont, CO 80504

March 10, 2022  
Amended January 13, 2023

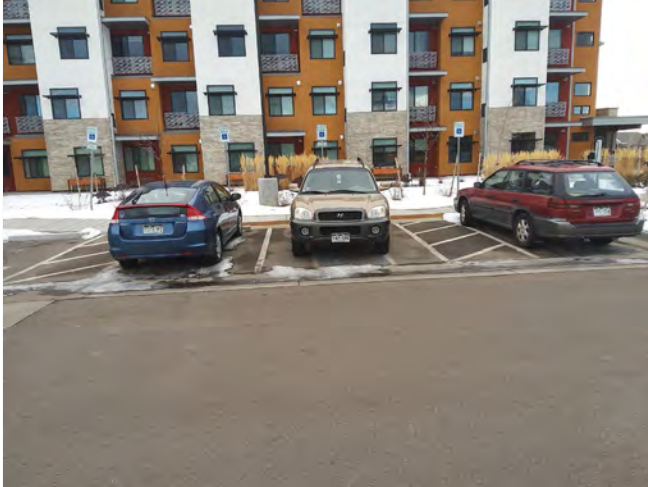
4.6.1, 4.1.1(5)(a) and 4.1.1(5)(d)(i)	Parking - Minimum and Accessible Sites	(1) Accessible parking space for each accessible dwelling unit plus 2% of the provided spaces for visitors. [(6) Accessible parking spaces for each accessible dwelling unit plus (3) accessible parking spaces for 60 visitor parking spaces = (9) total required.]	(4) accessible parking spaces have been provided on site. FR #1		(5) additional accessible parking spaces with access aisles are to be provided closest to the accessible entrance.	The estimated material cost to restripe approximately 1,500 square feet of the asphalt parking lot is \$400.00. The labor to restripe the asphalt parking lot is approximately 4 hours for a labor cost of \$280.00. Therefore, the material and labor estimated construction cost would be \$680.00.	\$680	\$680

Photo FR1 – (4) Accessible parking spaces near front entrance.

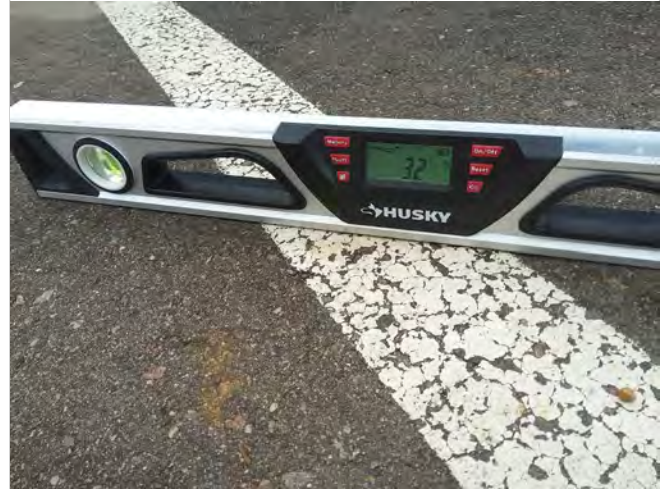
4.6.3	Parking Spaces	Parking spaces and access aisles shall be level with surface slopes not exceeding 1:50 in all directions.	A slope of 3.2% was measured at the accessible parking spaces. FR #2		Portions of the pavement at the accessible parking spaces and access aisles that exceed 2.0% should be reworked to have a slope less than 2%.	The estimated material cost to rework and restripe approximately 500 square feet of the asphalt parking lot is \$900.00. The labor to rework the asphalt parking lot is approximately 10 hours for a labor cost of \$700.00. Therefore, the material and labor estimated construction cost would be \$1,600.00.	\$1,600	\$680

Photo FR2 – Measured slope of 3.2% at accessible parking space.

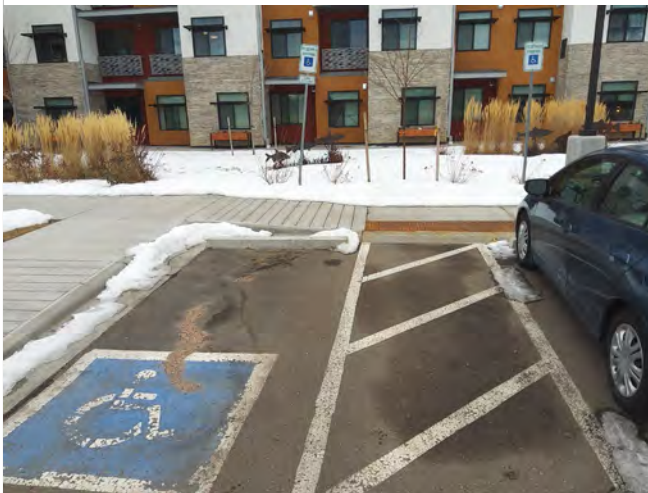
4.7.2, 4.8.2, and 4.8.6	Curb Ramp-Slope	Slope of curb ramps shall comply with 4.8.2 and 4.8.6.	The cross slope of the curb ramp at the front accessible route is measured at 2.4%.	FR #3 & FR #4	Remove and replace the existing concrete curb ramp.	The estimated material cost to install a new curb ramp is \$850.00. The labor to remove the existing curb ramp and install a new curb cut is 8 hours for a labor cost of \$560.00. Therefore, the material and labor estimated construction cost would be \$1,410.00.	\$1,410	\$1,410					
<b>Interior and Common Spaces</b>

Photo FR3 – Curb ramp on accessible route to front entrance.

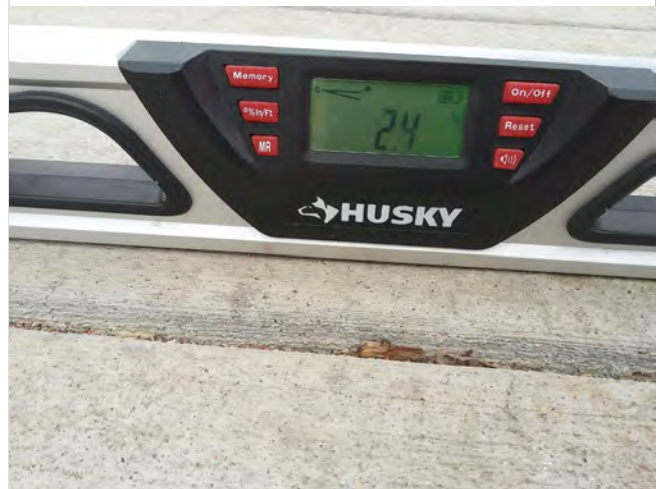
Photo FR4 – Measured cross slope of 2.4% at curb ramp on accessible route to front entrance.

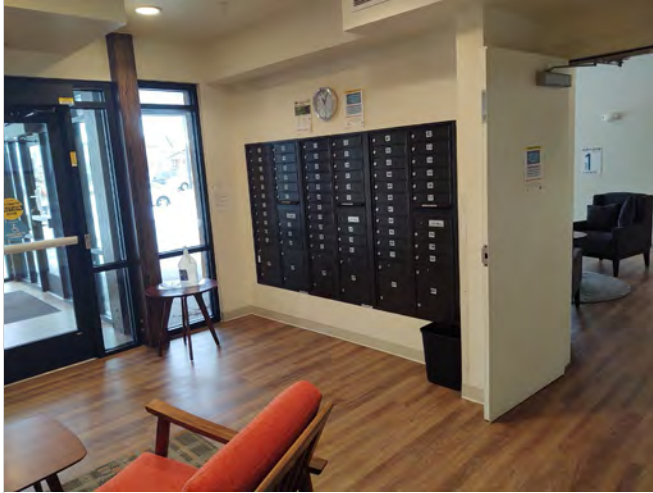
4.2.6	Mailboxes - Side Approach	The maximum high side reach allowed is 54" above the floor.	The height to the top of the mail boxes is 68 1/2"	FR #5 & FR #6	Residents with disabilities can request the U.S. Postal Service to accommodate their disability by assigning them a mailbox on the bottom row.	No cost	\$0.00	\$0.00

Photo FR5 – Mailbox bank in front lobby.

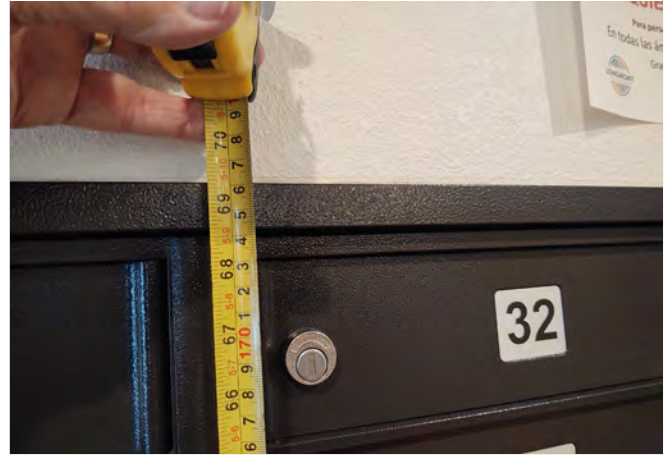
Photo FR6 – Measured height of 68 ½” to top of mailbox bank.

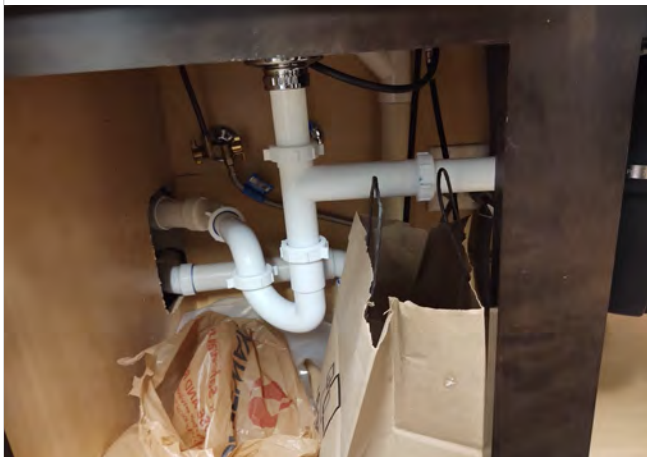
4.34.6.5(6)	Community Kitchen - Sink	There shall be no sharp or abrasive surfaces under sinks. Hot water and drain pipes under sinks shall be insulated or otherwise covered.	The hot water and drain piping are exposed.	FR #7	Install insulated covering over exposed piping.	The estimated material cost of the insulation covering is \$25.00. The labor to install the insulated covering is 1/2 hour for a labor cost of \$35.00. Therefore, the material and labor estimated construction cost would be \$60.00.	\$60	\$60					
<b>First Level Public Unisex Toilet Room</b>

Photo FR7 – Community Room – Kitchen sink with exposed piping.

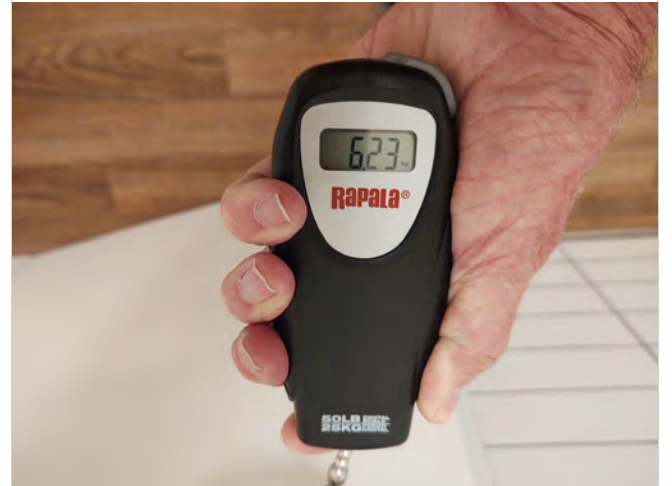
4.13.11	Door Opening Force	The maximum force for pulling open an interior hinged door is 5 lbf	The force to open the first level unisex rest room door is 6.23 lbs.	FR #8	The door closing mechanism is to be adjusted to allow the door to be opened with 5 lbs. maximum force.	The labor to adjust the door closing mechanism is approximately 1/2 hour for a labor cost of \$35.00.	\$35	\$35

Photo FR8 – First Level Unisex Toilet Room – Measured door pull of 6.23 lbs.

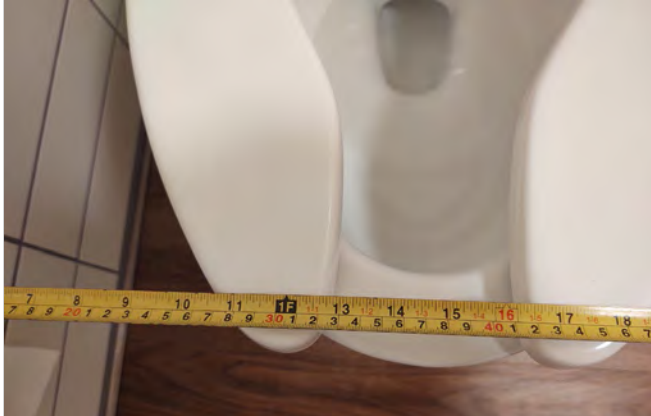
4.16.2 and Fig. 28	Clear Floor Space	The center line of the water closet is to be located between 17" and 19" from the side wall.	The center line of the water closet was measured to be 15" from the side wall.	FR #9	Remove and replace water closet so that the center line of the water closet is 18" from the side wall.	The estimated material cost to relocate the water closet is \$180.00. The labor to remove and replace the water closet is approximately 11 hour for a labor cost of \$770.00. Therefore, the parts and labor estimated construction cost would be \$950.00.	\$950			\$950						
<b>Third Level Unisex Toilet Room</b>

Photo FR9 – Second Level Unisex Toilet Room – Measured dimension of 15” to centerline of water closet.

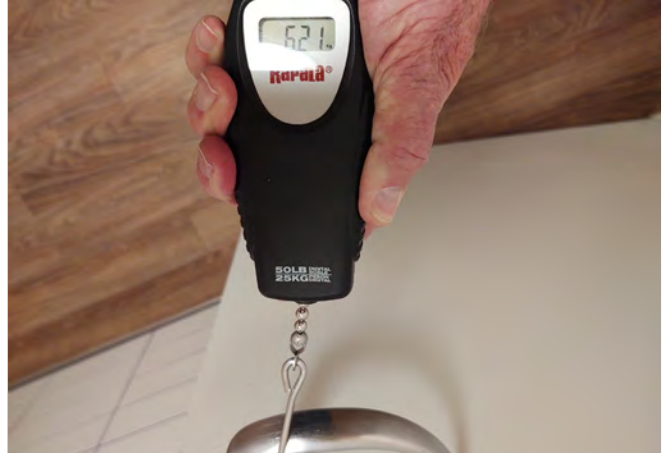
4.13.11	Door Opening Force	The maximum force for pulling open an interior hinged door is 5 lbf	The force to open the third level unisex rest room door is 6.21 lbs.	FR #10	The door closing mechanism is to be adjusted to allow the door to be opened with 5 lbs. maximum force.	The labor to adjust the door closing mechanism is approximately 1/2 hour for a labor cost of \$35.00.	\$35	\$35

Photo FR10 – Third Level Unisex Toilet Room – Measured door pull of 6.21 lbs.

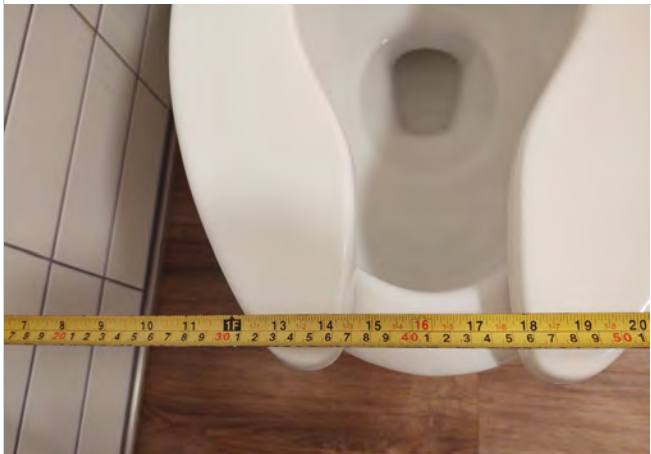
4.16.2 and Fig. 28	Clear Floor Space	The center line of the water closet is to be located between 17" and 19" from the side wall.	The center line of the water closet was measured to be 16 1/2" from the side wall.	FR #11	Remove and replace water closet so that the center line of the water closet is 18" from the side wall.	The estimated material cost to relocate the water closet is \$180.00. The labor to remove and replace the water closet is approximately 11 hour for a labor cost of \$770.00. Therefore, the parts and labor estimated construction cost would be \$950.00.	\$950	\$950								
<b>Fourth Level Unisex Toilet Room</b>

Photo FR11 – Third Level Unisex Toilet Room - Measured dimension of 16 ½” to centerline of water closet.

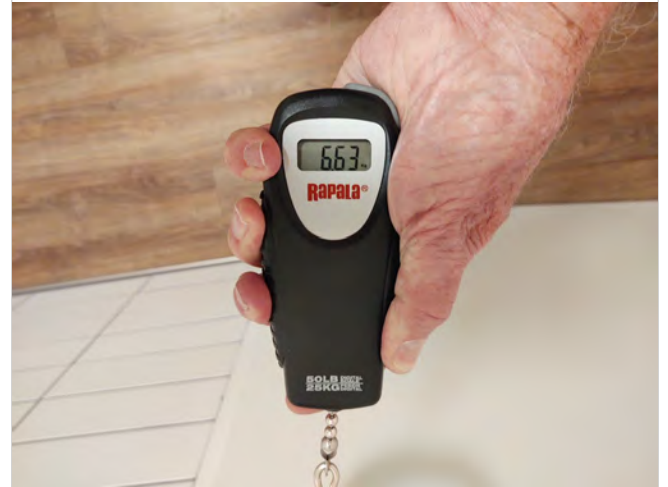
4.13.11	Door Opening Force	The maximum force for pulling open an interior hinged door is 5 lbf	The force to open the third level unisex rest room door is 6.63 lbs.	FR #12	The door closing mechanism is to be adjusted to allow the door to be opened with 5 lbs. maximum force.	The labor to adjust the door closing mechanism is approximately 1/2 hour for a labor cost of \$35.00.	\$35	\$35

Photo FR12 – Fourth Level Unisex Toilet Room - Measured door pull of 6.63 lbs.

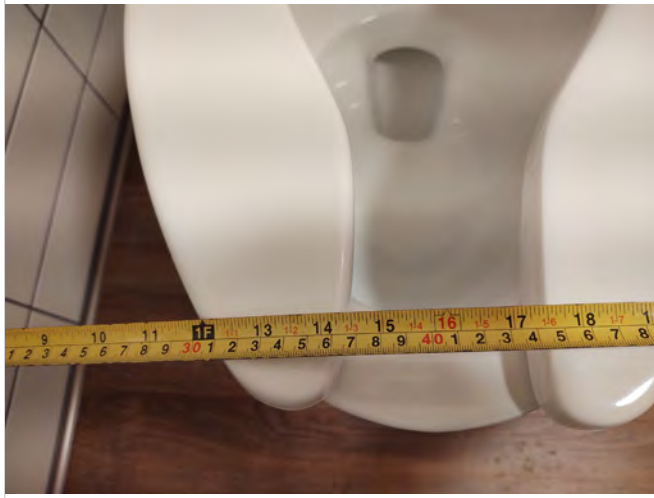
4.16.2 and Fig. 28	Clear Floor Space	The center line of the water closet is to be located between 17" and 19" from the side wall.	The center line of the water closet was measured to be 16" from the side wall.	FR #13	Remove and replace water closet so that the center line of the water closet is 18" from the side wall.	The estimated material cost to relocate the water closet is \$180.00. The labor to remove and replace the water closet is approximately 11 hour for a labor cost of \$770.00. Therefore, the parts and labor estimated construction cost would be \$950.00.	\$950	\$950								
<b>Third Level Laundry Room</b>

Photo FR13 – Fourth Level Unisex Toilet Room - Measured dimension of 16" to centerline of water closet.

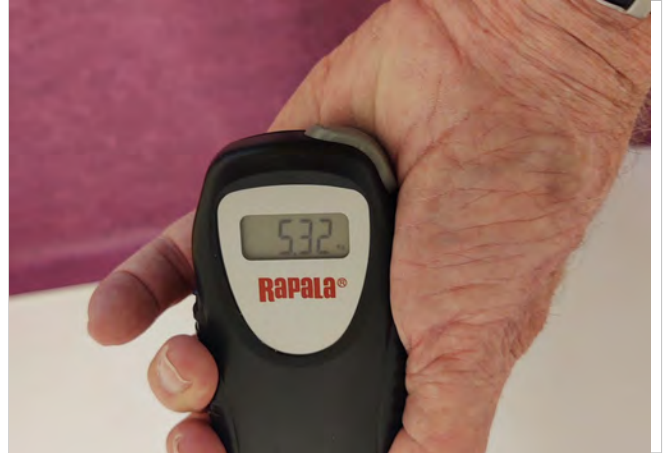
4.13.11	Door Opening Force	The maximum force for pulling open an interior hinged door is 5 lbf	The force to open the first level unisex rest room door is 5.23 lbs.	FR #14	The door closing mechanism is to be adjusted to allow the door to be opened with 5 lbs. maximum force.	The labor to adjust the door closing mechanism is approximately 1/2 hour for a labor cost of \$35.00.	\$35	\$35								
<b>Accessible Dwelling Unit; Guest Room #107; 2-Bedroom</b>

Photo FR14 – Third Level Laundry Room – Measured door pull or 5.32 lbs.

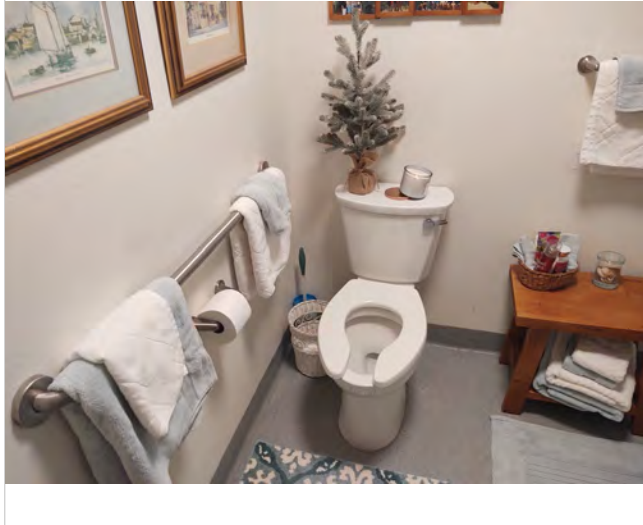
4.17.6, 4.26, Fig. 29, and Fig. 30(c)	Rear Grab Bar	Rear grab bars shall be provided between 33 and 36" above the floor and shall be 36" in length.	No rear grab bar has been provided.	FR #15	A new 36" long grab bar installed.	The estimated cost of the new rear wall grab bar is \$50.00. The labor to install a new rear wall grab bar is approximately 4 hour for a labor cost of \$280.00. Therefore, the parts and labor estimated construction cost would be \$330.00.	\$330	\$330

Photo FR15 – Dwelling Unit #107 – Bathroom with no rear grab bar.

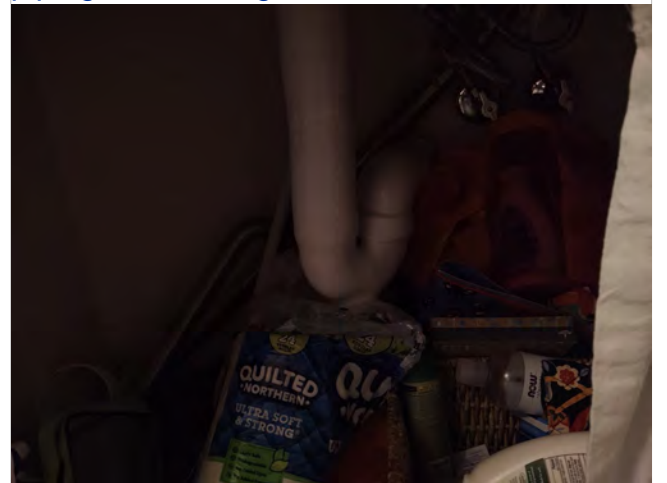
4.34.6.5(8)	Bathroom Sink	There shall be no sharp or abrasive surfaces under sinks. Hot water and drain pipes under sinks shall be insulated or otherwise covered.	The hot water and drain piping are exposed.	FR #16	Install insulated covering over exposed piping.	The estimated material cost of the insulation covering is \$25.00. The labor to install the insulated covering is 1/2 hour for a labor cost of \$35.00. Therefore, the material and labor estimated construction cost would be \$60.00.	\$60	\$60

Photo FR16 – Dwelling Unit #107 - Exposed piping and flooring beneath bathroom sink.

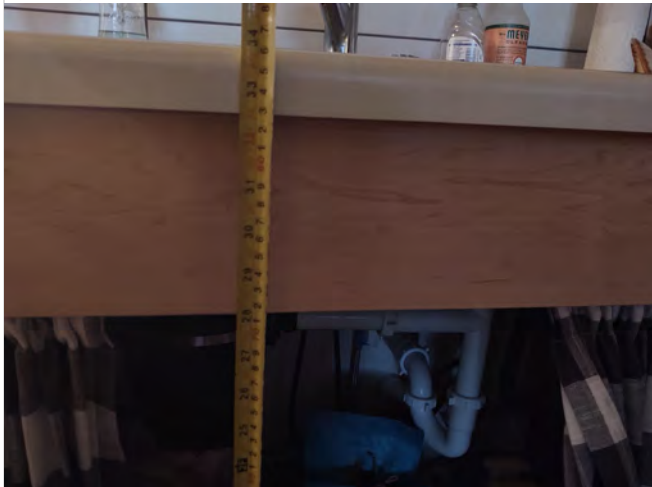
4.34.6.5(8)	Kitchen Sink	There shall be no sharp or abrasive surfaces under sinks. Hot water and drain pipes under sinks shall be insulated or otherwise covered.	The hot water and drain piping are exposed.	FR #17	Install insulated covering over exposed piping.	The estimated material cost of the insulation covering is \$25.00. The labor to install the insulated covering is 1/2 hour for a labor cost of \$35.00. Therefore, the material and labor estimated construction cost would be \$60.00.	\$60	\$60								
<b>Accessible Dwelling Unit; Guest Room #207; 2-Bedroom</b>

Photo FR17 – Dwelling Unit #107 - Exposed piping beneath kitchen sink.

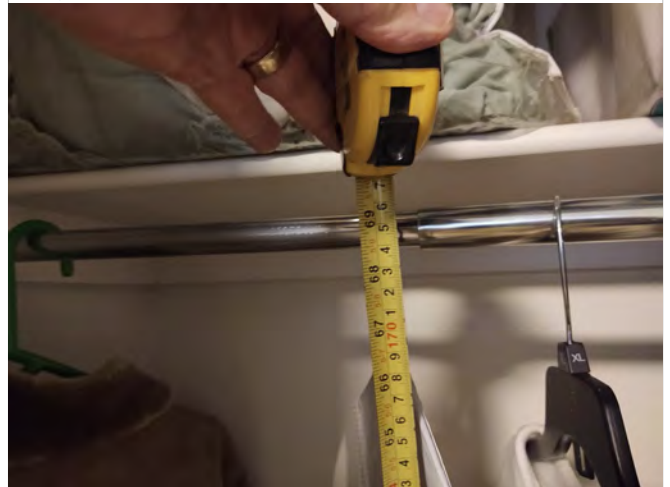
4.25.3 and 4.2.6	Storage - Height	Clothes rods shall be a maximum of 54" from the floor.	The measured top of the clothes rod was 69".	FR #18	The existing clothes rod is to be lowered to not more than 54" above the floor.	The labor to relocate the clothes rod is approximately 1 hour for a labor cost of \$70.00.	\$70	\$70

Photo FR18 – Dwelling Unit #207 - Measured height of 69” at clothes rod.

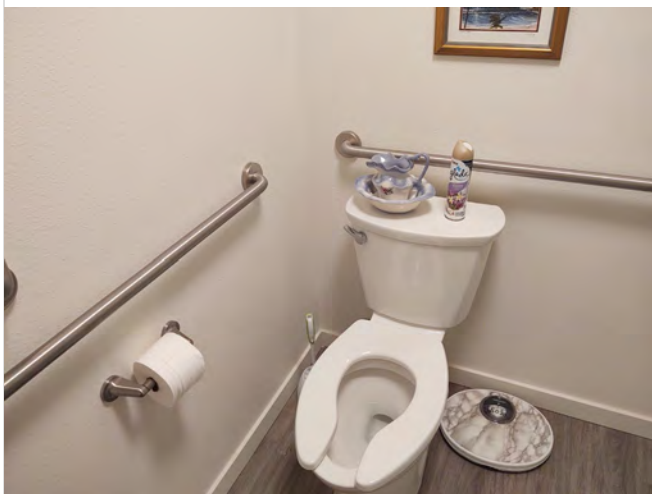
4.16.5	Water Closets - Flush Controls	Controls for flush valves shall be mounted on the wide side of toilet areas	The flush control valve is located on the wall side of the water closet.	FR #19	Remove and replace water tank with flush control on wide side of water closet.	The estimated cost of a new "right hand" water tank is \$75.00. The labor to replace the water tank is approximately 1 hour for a labor cost of \$70.00. Therefore, the parts and labor estimated construction cost would be \$145.00.	\$145	\$145

Photo FR19 – Dwelling Unit #207 - Flush control on wall side of water closet.

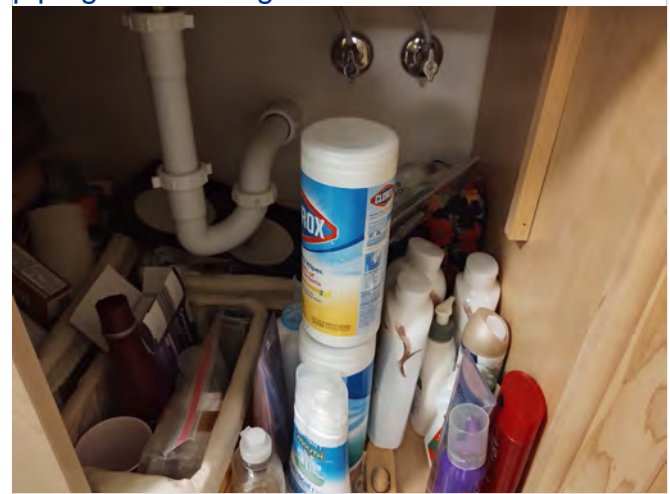
4.34.6.5(8)	Bathroom Sink	There shall be no sharp or abrasive surfaces under sinks. Hot water and drain pipes under sinks shall be insulated or otherwise covered.	The hot water and drain piping are exposed.	FR #20	Install insulated covering over exposed piping.	The estimated material cost of the insulation covering is \$25.00. The labor to install the insulated covering is 1/2 hour for a labor cost of \$35.00. Therefore, the material and labor estimated construction cost would be \$60.00.	\$60	\$60

Photo FR20 – Dwelling Unit #207 - Exposed piping and flooring beneath bathroom sink.

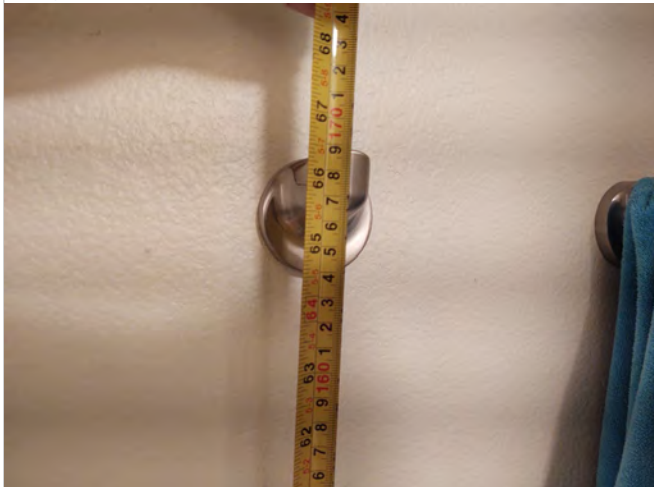
4.23.7, 4.27, 4.2.5 and 4.2.6	Dispensers and Other Elements	Coat hooks shall be a maximum of 54" from the floor	The measured dimension to the top of the coat hook is 66"	FR #21	Another coat hook is to be installed to not more than 54" above the floor.	The estimated cost of a new coat hook is \$25.00. The labor to install the new coat hook is approximately 1/2 hour for a labor cost of \$35.00. Therefore, the parts and labor estimated construction cost would be \$60.00.	\$60	\$60								
<b>Accessible Dwelling Unit; Guest Room #212; 1-Bedroom</b>

Photo FR21 – Dwelling Unit #207 - Measured height of 66" at coat hook.

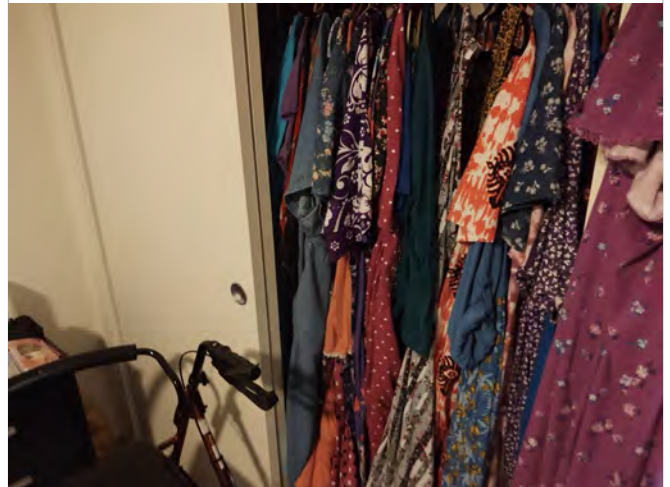
4.25.3 and 4.2.6	Storage - Height	Clothes rods shall be a maximum of 54" from the floor	The top of the clothes rod exceeded 54".	FR #22	The existing clothes rod is to be lowered to not more than 54" above the floor.	The labor to relocate the clothes rod is approximately 1 hour for a labor cost of \$70.00.	\$70	\$70

Photo FR22 – Dwelling Unit #212 – Clothes rod exceeds 48".

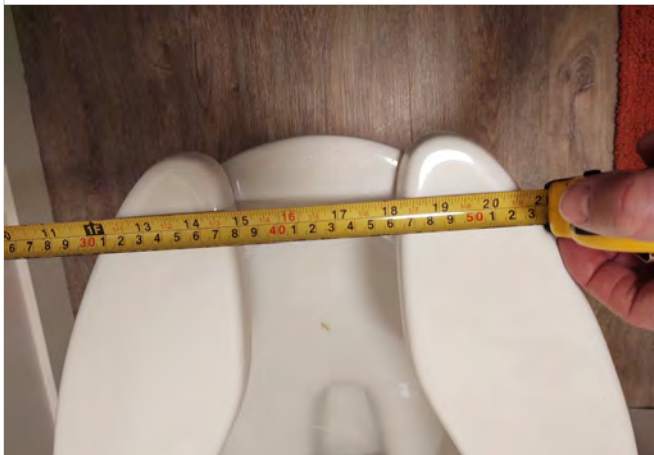
4.16.2 and Fig. 28	Clear Floor Space	The center line of the water closet is to be located between 17" and 19" from the side wall	The center line of the water closet was measured to be 16 1/2" from the side wall.	FR #23	Remove and replace water closet so that the center line of the water closet is 18" from the side wall.	The estimated material cost to relocate the water closet is \$180.00. The labor to remove and replace the water closet is approximately 11 hour for a labor cost of \$770.00. Therefore, the parts and labor estimated construction cost would be \$950.00.	\$950	\$950

Photo FR23 – Dwelling Unit #212 - Measured dimension of 16 1/2" to centerline of water closet.

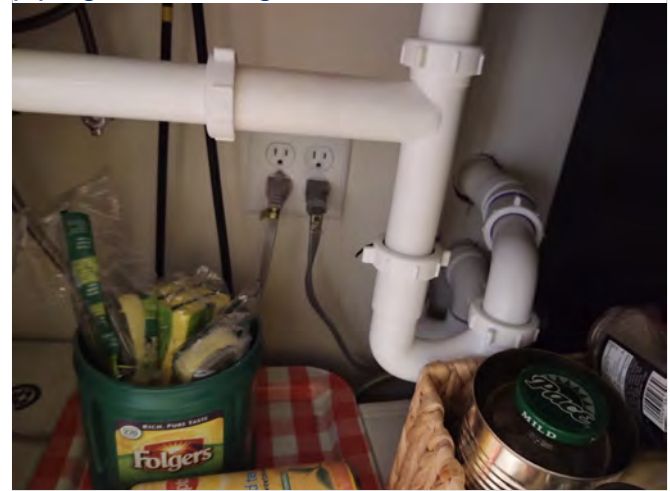
4.34.6.5(8)	Kitchen Sink	There shall be no sharp or abrasive surfaces under sinks. Hot water and drain pipes under sinks shall be insulated or otherwise covered.	The hot water and drain piping are exposed.	FR #24	Install insulated covering over exposed piping.	The estimated material cost of the insulation covering is \$25.00. The labor to install the insulated covering is 1/2 hour for a labor cost of \$35.00. Therefore, the material and labor estimated construction cost would be \$60.00.	\$60	\$60								
<b>Accessible Dwelling Unit; Guest Room #414; 1-Bedroom</b>

Photo FR24 – Dwelling Unit #212 - Exposed piping and flooring beneath Kitchen sink.

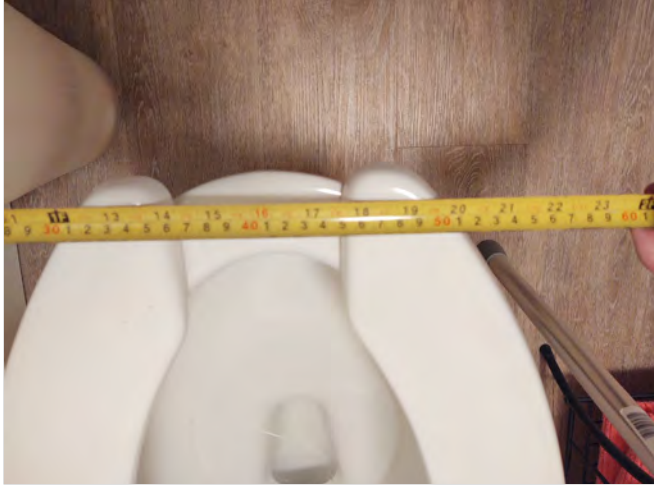
4.16.2 and Fig. 28	Clear Floor Space	The center line of the water closet is to be located between 17" and 19" from the side wall	The center line of the water closet was measured to be 16" from the side wall.	FR #25	Remove and replace water closet so that the center line of the water closet is 18" from the side wall.	The estimated material cost to relocate the water closet is \$180.00. The labor to remove and replace the water closet is approximately 11 hour for a labor cost of \$770.00. Therefore, the parts and labor estimated construction cost would be \$950.00.	\$950	\$950

Photo FR25 – Dwelling Unit #414 - Measured dimension of 16" to centerline of water closet.

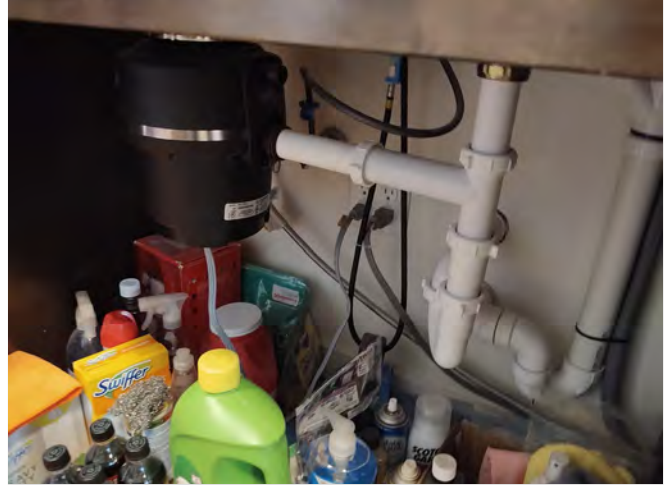
4.34.6.5(8)	Kitchen Sink	There shall be no sharp or abrasive surfaces under sinks. Hot water and drain pipes under sinks shall be insulated or otherwise covered.	The hot water and drain piping are exposed.	FR #26	Install insulated covering over exposed piping.	The estimated material cost of the insulation covering is \$25.00. The labor to install the insulated covering is 1/2 hour for a labor cost of \$35.00. Therefore, the material and labor estimated construction cost would be \$60.00.	\$60	\$60								
24 C.F.R. §§ 8.22 & 8.23	Dwelling Units for persons with hearing or visual Impairment.	2% of 50 units = 1.2 unit (use 2 unit)	No dwelling units for persons with hearing or vision impairment have been designated.		(2) Dwelling units should be provided for persons with hearing or vision impairment.	Estimated cost to renovate (2) existing dwelling units to be acceptable for person with hearing or vision impairment is \$5,000.00 per unit for a total estimated cost of \$10,000.00	\$10,000	\$10,000			\$10,000

Photo FR26 – Dwelling Unit #414 - Exposed piping and flooring beneath Kitchen sink.
