## CORRECTIVE ACTION PLAN

## Aspen Meadows Apartments

70 21<sup>st</sup> Avenue  
Longmont, CO 80501

March 3, 2022  
Amended January 13, 2023

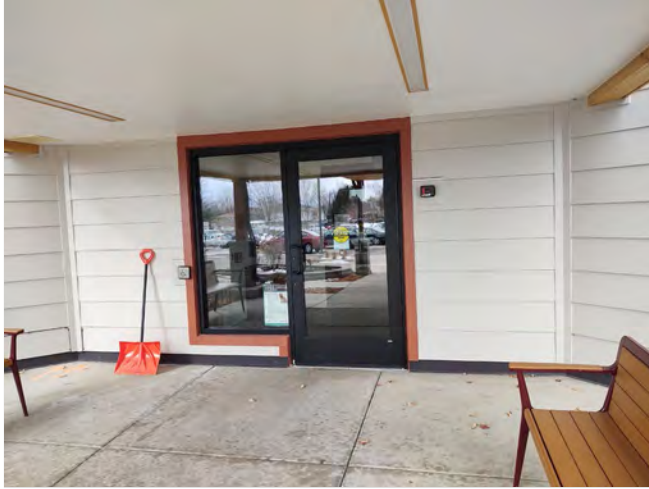
4.1.1(7)(c) and 4.30.5	Entrance Signage	If not all common use entrances are accessible, the accessible entrances and the non-accessible entrances shall be identified.	The front entrance to the housing units is accessible but the (2) side entrances are not accessible.	AM #1, AM #2 & AM #3	Signage indicating accessibility are to be installed at the front entrance. Signage indicating non-accessibility are to be installed adjacent to the non-accessible side entrances.	The estimated cost of the 1 new accessible sign is \$30.00. The estimated cost of the 2 new signs indicating non-accessibility with posts is \$120.00. The labor to install the 3 new signs is approximately 3 hours for a labor cost of \$210.00. Therefore, the parts and labor estimated construction cost would be \$360.00.	\$360							
<b>Interior and Common Spaces</b>

Photo AM1 – Front accessible entrance without signage.

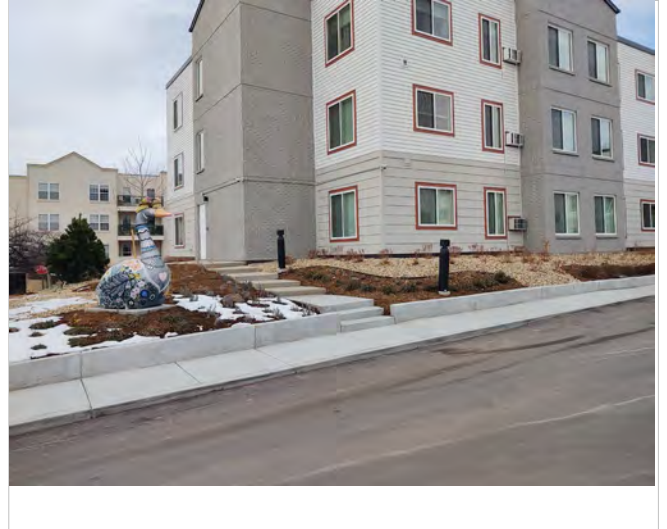
Photo AM2 – Non-accessible side door.

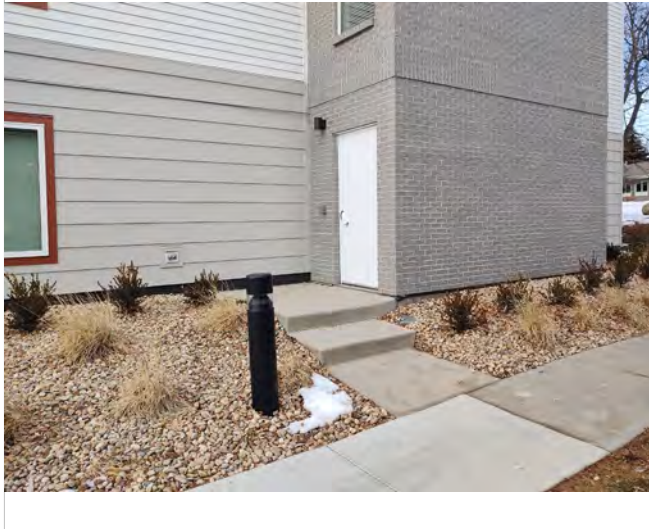
Photo AM3 – Non-accessible side door.

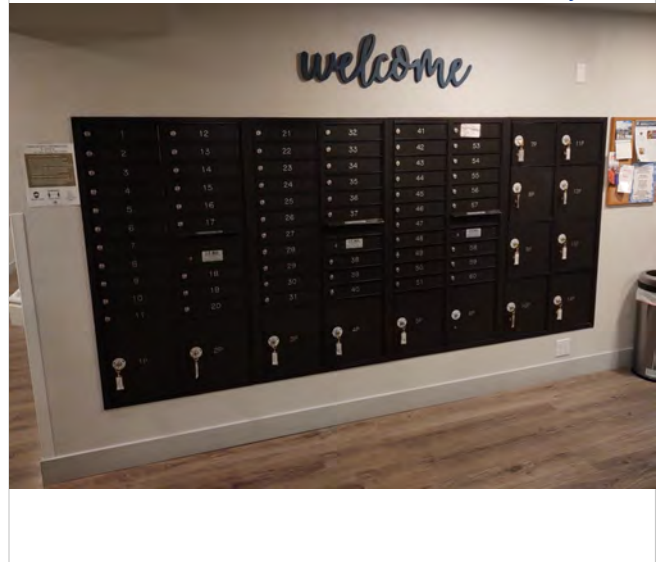
4.2.6	Mailboxes - Side Approach	The maximum high side reach allowed is 54" above the floor.	The height to the top of the mail boxes is 69 1/2"	AM #4 & AM #5	<b>Residents with disabilities can request the U.S. Postal Service to accommodate their disability by assigning them a mailbox on the bottom row.</b>	No cost	\$0						Completed	
<b>First Level Public Unisex Toilet Room</b>

Photo AM4 – Mailbox bank in front lobby.

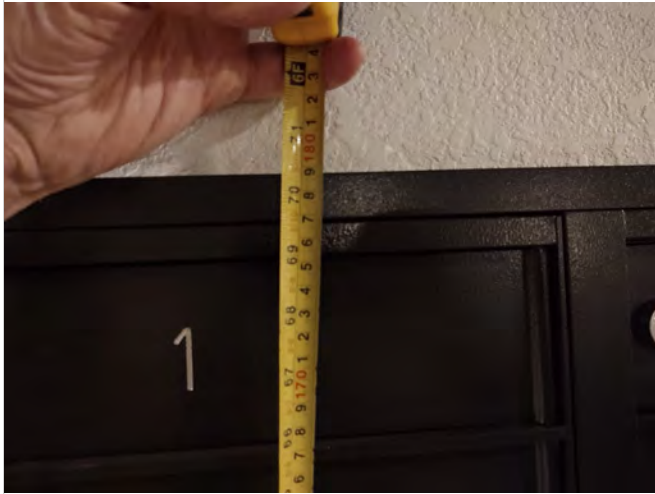
Photo AM5 – Measured height of 69 ½” to top of mailbox bank.

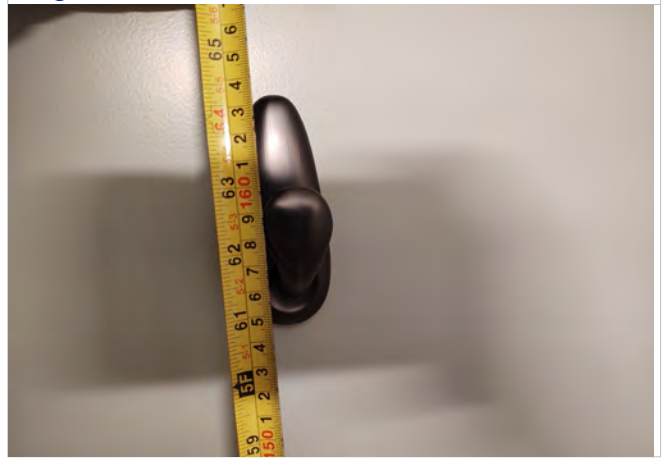
4.2.5, 5(a), 4.2.6, and Fig. 6(e)	Forward Reach and Side Reach	The maximum high forward reach allowed shall be 48" above the floor. The maximum high side reach allowed is 54" above the floor.	The coat hook is located 62" above the floor.	AM #6	The existing coat hook is to be relocated to be not more than 48" above the floor.	The labor to relocate the coat hook is approximately 1/2 hour for a labor cost of \$35.00.	\$35							
<b>Second Level Public Women's Toilet Room</b>

Photo AM6 – Unisex Toilet Room – Measured height of 62” to coat hook.

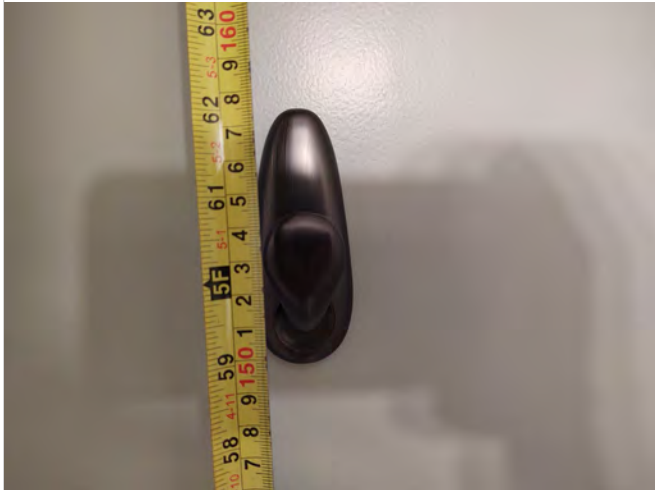
4.2.5, 5(a), 4.2.6, and Fig. 6(a)	Forward Reach and Side Reach	The maximum high forward reach allowed shall be 48" above the floor. The maximum high side reach allowed is 54" above the floor.	The coat hook is located 60" above the floor.	AM #7	The existing coat hook is to be relocated to be not more than 48" above the floor.	The labor to relocate the coat hook is approximately 1/2 hour for a labor cost of \$35.00.	\$35							
<b>Accessible Dwelling Unit; Guest Room #104; 1-Bedroom</b>

Photo AM7 – Women’s Toilet Room – Measured height of 60” to coat hook.

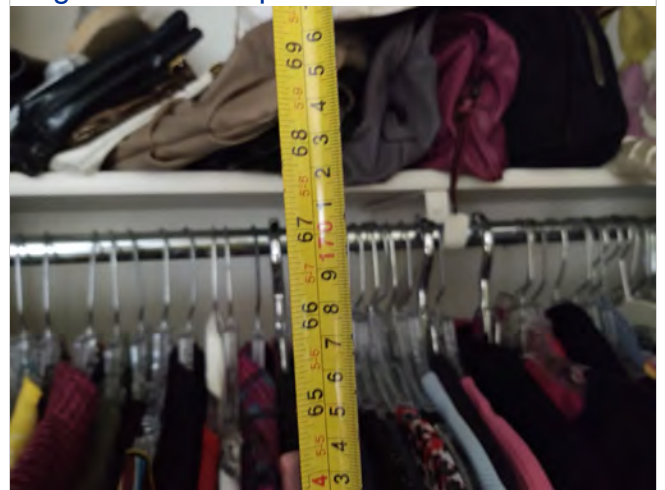
4.2.5.3 and 4.2.6	Storage - Height	Clothes rods shall be a maximum of 54" from the floor.	The measured top of the clothes rod was 67".	AM #8	The existing clothes rod is to be lowered to not more than 54" above the floor.	The labor to relocate the clothes rod is approximately 1 hour for a labor cost of \$70.00.	\$70							
<b>Accessible Dwelling Unit; Guest Room #115; 1-Bedroom</b>

Photo AM8 – Dwelling Unit #104 – Measured height of 67” to top clothes rod.

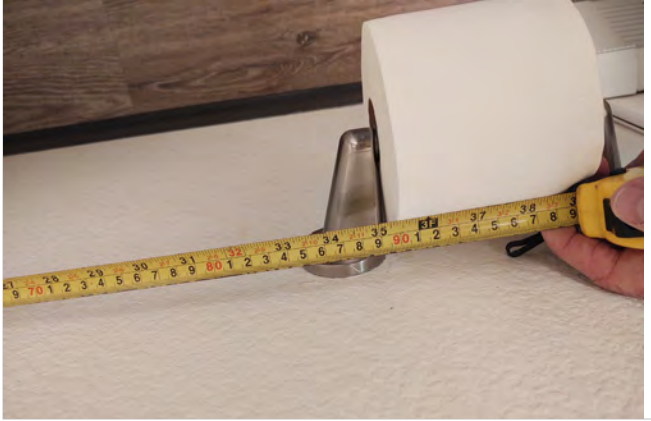
4.34.5.2(a) and Fig. 47(b)	Water Closets - Dispensers	Starting at the edge farthest from the back wall, the toilet paper dispenser is no more than 36" from the back wall.	The far reach of the toilet paper dispenser is approximately 42" from the back wall.	AM #9	Relocate the toilet paper dispenser to be within 36" from back wall.	The labor to remove and relocate the existing toilet paper dispenser is approximately 2 hours for a labor cost of \$140.00.	\$140							
<b>TOTAL</b>							\$640.00	\$640.00	\$0.00	\$0.00	\$0.00	\$0.00	\$0.00	\$0.00

Photo AM9 – Dwelling Unit #115 – Measured distance of toilet paper dispenser exceeds 36” to far edge.
