CORRECTIVE ACTION PLAN

Briarwood Apartments

1227 Kimbark Street
Longmont, CO 80501

February 22, 2022
Amended January 13, 2023

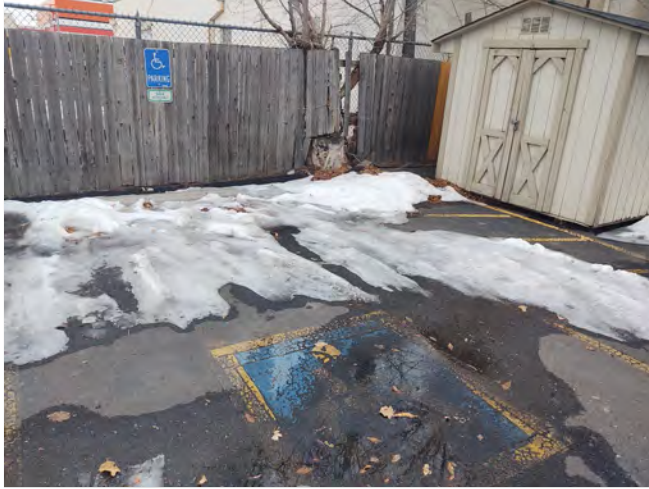
Photo B1 – Accessible parking space and adjacent access aisle.

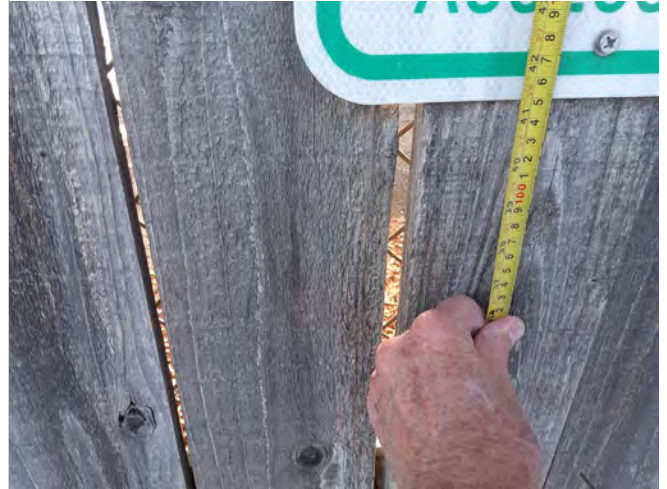
4.6.4 and 4.1.1(7)(a)	Parking - Signage and Accessible Sites	Accessible parking spaces shall be designated as reserved by a sign.	The signage in front of the accessible parking space is measured to be approximately 41 1/2" above the ground. B #1		(1) Additional accessible parking space sign is to be provided. The existing accessible parking sign and "van accessible" sign is to be relocated to be a minimum of 60 inches above the ground. B #2	The estimated cost of the (1) new accessible sign is \$30.00. The labor to relocate the existing signs and install the new sign is approximately 1 hour for a labor cost of \$70.00. Therefore, the parts and labor estimated construction cost would be \$100.00.	\$100	\$100

Photo B2 – Measured height to bottom of “Van Accessible” sign is 41 ½”

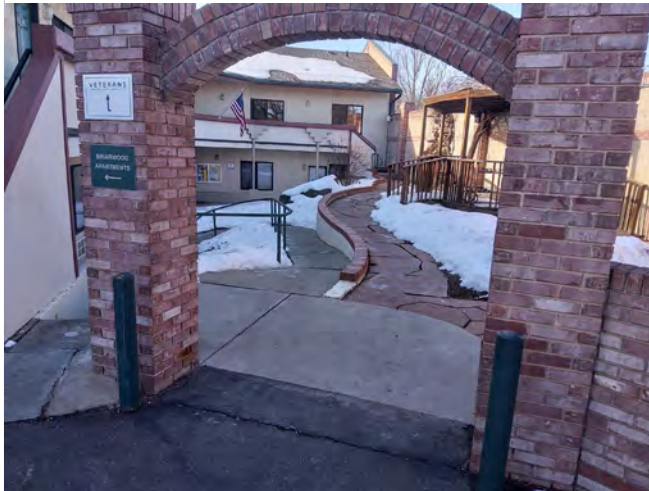
4.8.2, 4.8.6, and 4.8.7	Ramps - Slope and Rise, Cross Slopes and Surfaces, & Edge Protection	Maximum running slope of a ramp shall be 1:12 (8.3%), maximum cross slope shall be 1:50 (2.0%), and edge protection shall be provided.	The running and cross slopes of the ramp exceed the allowable slopes. No compliant edge protection and landings have been provided. B #3, B #4, B #5, & B #6		Remove and replace the existing concrete ramp and handrails. The ramp should tie into the accessible routes at both the top and bottom of the ramp. B #3, B #4, B #5, & B #6	The estimated material cost to construct a new 60 foot long ramp with landings and handrails is \$15,000.00. The labor to construct a new 60 foot long ramp with landings and handrails is approximately 250 hours for a labor cost of \$17,500.00. Therefore, the material and labor estimated construction cost would be \$32,500.00.	\$32,500	\$32,500

Photo B3 – Ramp at Accessible Route to lower level of dwelling units.

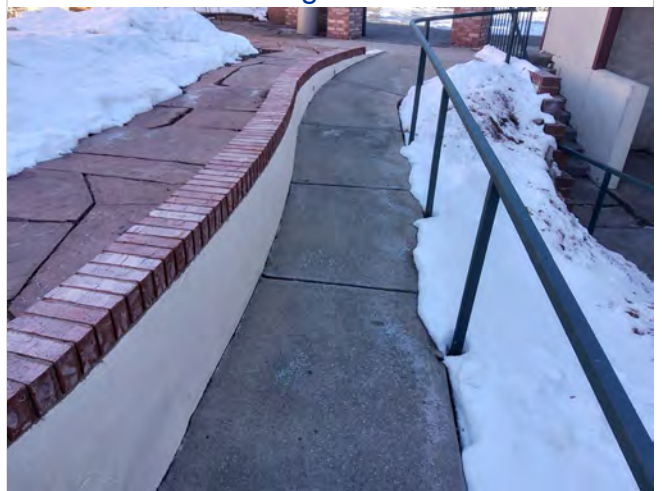
Photo B4 – Ramp at Accessible Route to lower level of dwelling units.

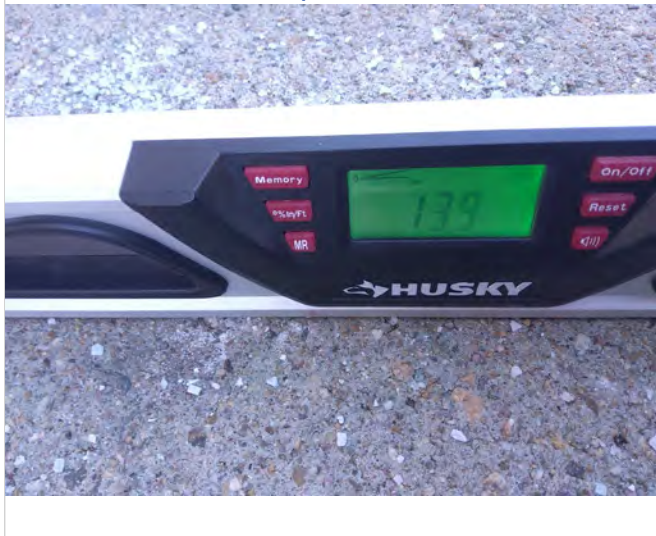
Photo B5 – Measured running slope of accessible route ramp is 13.9%

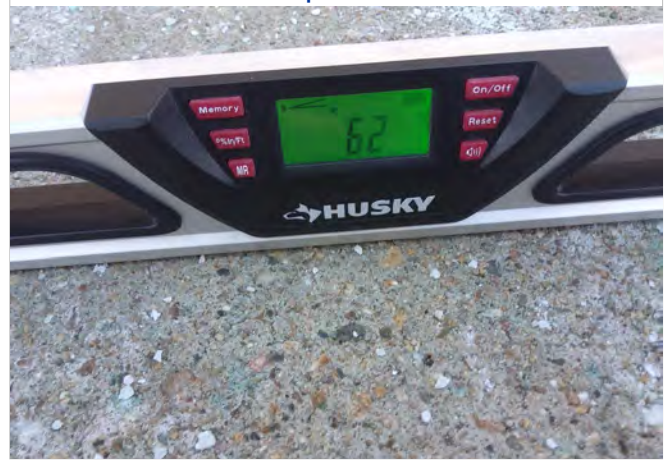
Photo B6 – Measured cross slope of accessible route ramp is 6.2%

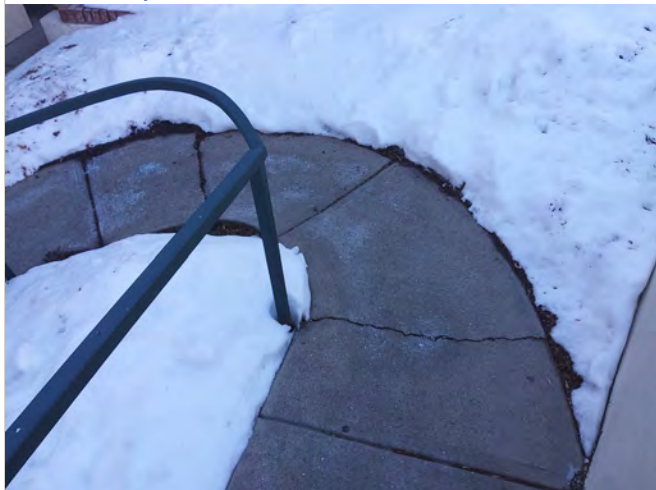
4.8.4	Ramps - Landings	Ramps shall have landings at the bottom and top of each run. The landing length shall be a minimum of 60 inches and at the change in directions, the landing shall be a minimum of 60" by 60".	No landing has been provided at the change of direction on the ramp. The length of the landing at the bottom of the ramp is approximately 44 inches in length. B #7, B #8, & B #9		Construction of the landings to be connected with the concrete ramp in Section 4.8.2 above..	Refer to item 4.8.2 above for the cost to construct the integral landings.	\$0.00	\$0							
Interior and Common Spaces

Photo B7 – Curve at middle of accessible route ramp.

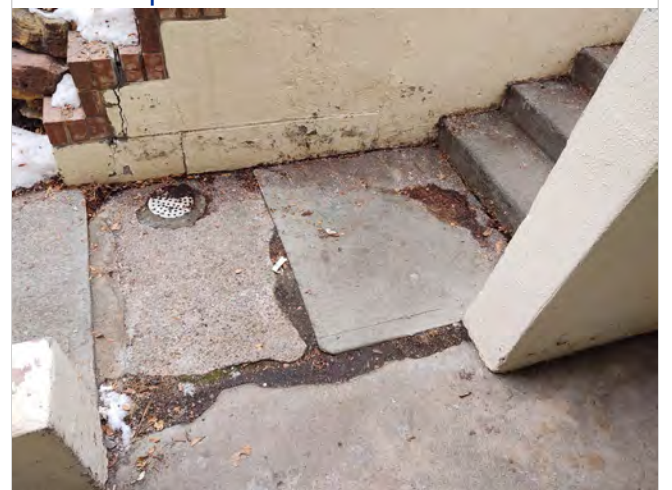
Photo B8 – Landing at bottom of accessible route ramp.

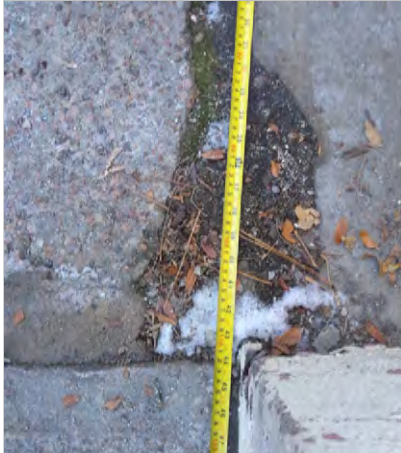
Photo B9 – Measured length of landing at the bottom of the accessible route ramp is 44.”

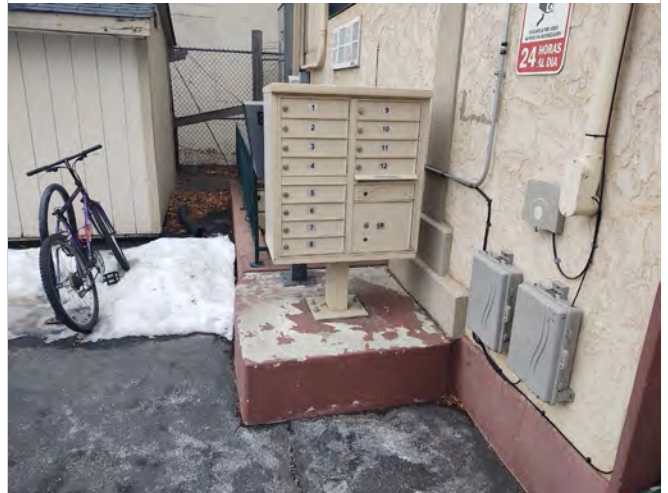
4.2.6	Mailboxes - Side Approach	The maximum high side reach allowed is 54" above the floor or ground.	The height to the top of the exterior mail boxes is 63". B #10 & B #11		Residents with disabilities can request the U.S. Postal Service to accommodate their disability by assigning them a mailbox on the bottom row.	No cost.	\$0	\$0							
Accessible Dwelling Unit; Guest Room #104 - Studio

Photo B10 – Exterior bank of Mailboxes.

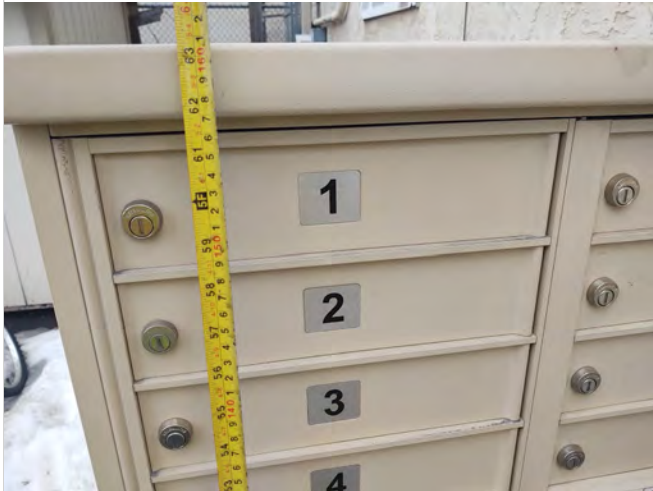
Photo B11 – Measure height to top of exterior bank of mailboxes is 61.”

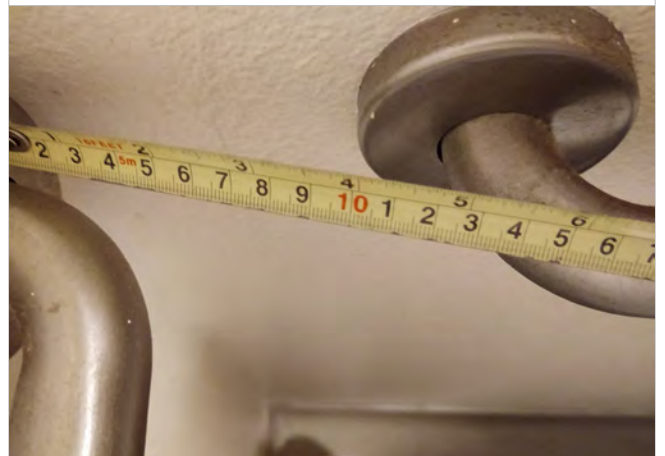
4.3.4.5.2(3), 4.2.6, and Fig. 29	Side Wall Grab Bar	The side wall grab should be no more than 12 inches from the back wall and 42 inches long.	The measured distance from the back wall to the near edge of the side wall grab bar is 5". The measured distance from the back wall to the far edge of the side wall grab bar is 47". B # 12 & B #13		The existing 42" long side wall grab bars is to be relocated to have the near edge 12" from the back wall.	The labor to re-position the existing side wall grab bar is approximately 3 hours for a labor cost of \$210.00.	\$210	\$210

Photo B12 – Dwelling Unit #104 - Measured near end of the side wall grab bar is 5” from the back wall.

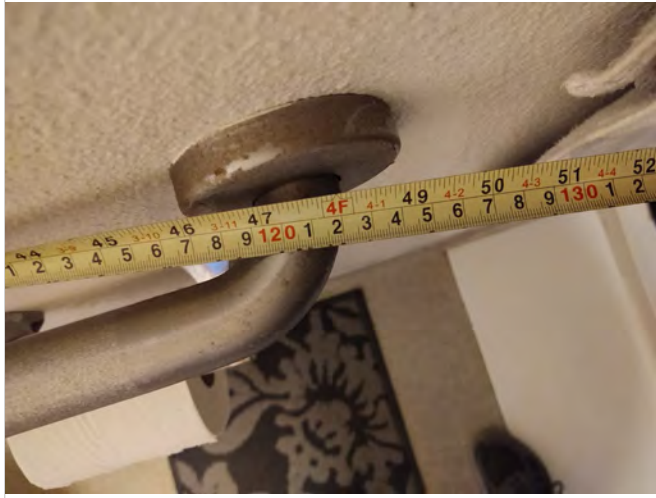
Photo B13 – Dwelling Unit #104 - Measured far end of the side wall grab bar is 47” from the back wall.

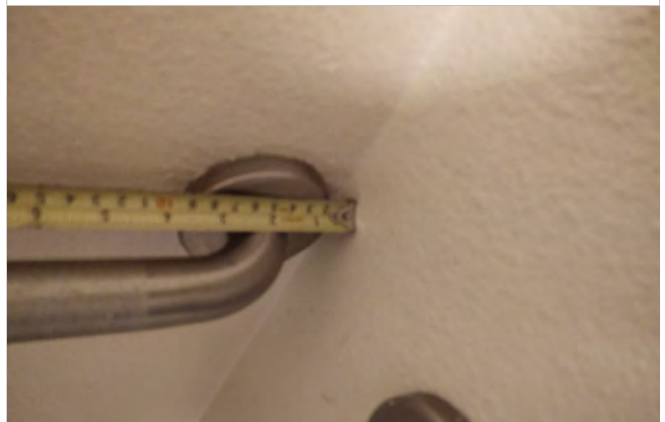
4.34.5.2(3), 4.26, and Fig. 29	Rear Wall Grab Bar	The rear wall grab bar should be no more than 6 inches from the side wall and 32 inches long. Starting at the edge farthest from the back wall, the toilet paper dispenser is no more than 36" from the back wall.	The measured distance from the side wall to the rear edge of the rear wall grab bar is 2". The measured distance from the side wall to the far edge of the rear wall grab bar is 38".	B # 14 & B # 15	The existing 36" long rear wall grab bar is to be relocated to have the rear edge 6" from the side wall.		\$210		\$210

Photo B14 – Dwelling Unit #104 - Measured near end of the rear wall grab bar is 2” from the side wall.

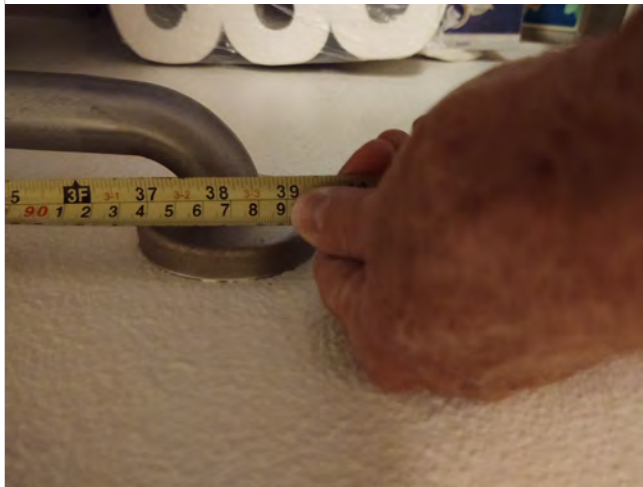
Photo B15 – Dwelling Unit #104 - Measured far end of the rear wall grab bar is 38” from the side wall.

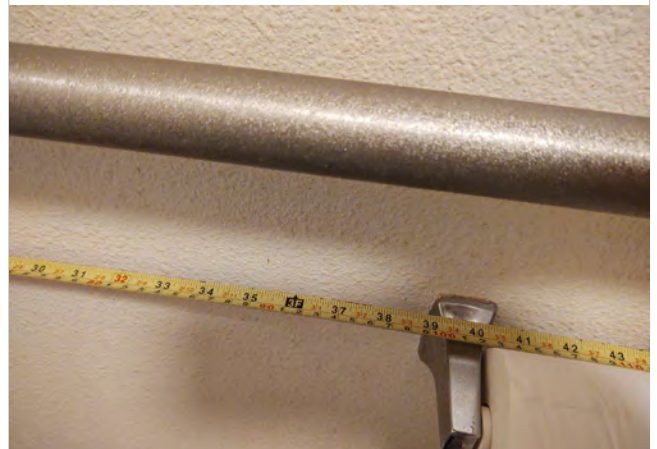
4.34.5.2(4) and Fig. 47(b)	Toilet Paper Dispenser		The edge of the toilet paper dispenser is greater than 36 inches from the back wall.	B # 16	The existing toilet paper dispenser is to be located so the farthest edge is not more than 36" from the rear wall.		\$140		\$140							
24 C.F.R §§ 8.22 & 8.23																
	Dwelling Units for persons with hearing or visual Impairment.	2% of 10 units = 0.2 units (use 1 unit)	No dwelling units for persons with hearing or vision impairment have been designated.		(1) Dwelling unit should be provided for persons with hearing or vision impairment.	Estimated cost to renovate (1) existing dwelling unit to be acceptable for persons with hearing or vision impairment is \$5,000.00 per unit.	\$5,000				\$5,000					
TOTAL							\$39,760.00	\$100.00	\$2,160.00	\$32,500.00	\$5,000.00	\$0.00	\$0.00	\$0.00	\$0.00	\$0.00

Photo B16 – Dwelling Unit #104 - Measured near edge of the toilet paper dispenser at 39” from the back wall.
