CORRECTIVE ACTION PLAN

With TRANSITION PLAN

Commercial Property located at

1228 Main Street

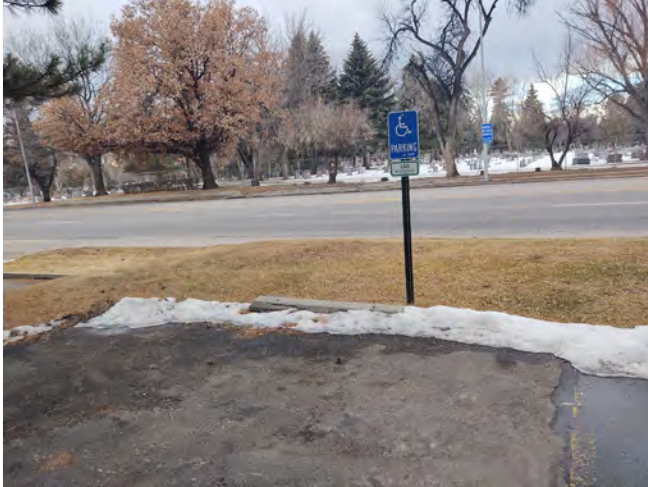
4.6.4 and 4.1.1(7)(a)	Parking - Signage and Accessible Sites	Accessible parking spaces shall be designated as reserved by a sign.	The signage in front of the existing accessible parking space is located less than 60" above the ground.	CL #1 & CL #2	The existing sign is to be relocated a minimum of 60" above the ground.	The estimated labor to relocate the sign is approximately 1/2 hour for a labor cost of \$35.00.	\$35.00

Photo CL1 – Signage in front of accessible parking space.

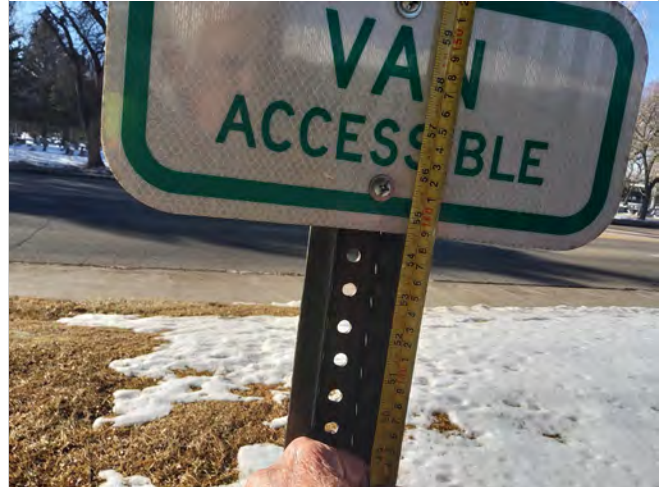
Photo CL2 – Measured height of 54 ½” to bottom of accessible parking sign.

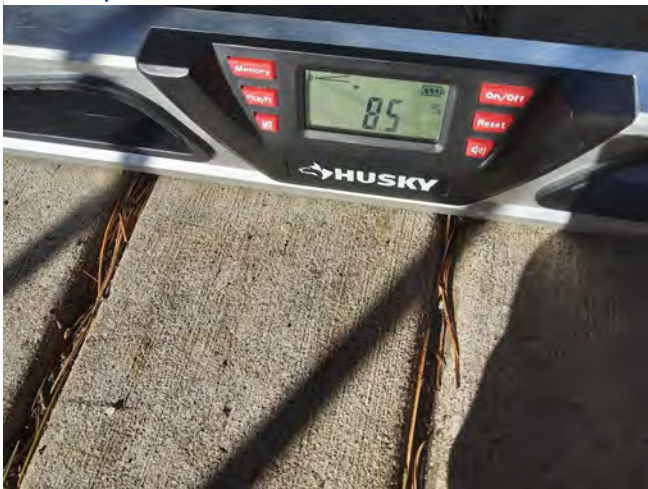
4.8.2 and 4.8.4	Ramps - Slope and Rise & Landings	Maximum running slope of a ramp shall be 1:12 (8.3%). If ramps change direction at landings, the minimum landing size shall be 60" by 60".	The running slopes of the ramp exceeds the allowable slopes. The landing at the lower change in direction is less than 60" by 60".	CL #3 & CL #4	Remove and replace the existing concrete and expanded metal ramp.	The estimated material cost to construct a new 50 foot long ramp with handrails is \$12,500.00. The labor to construct a new 50 foot long ramp with handrails is approximately 210 hours for a labor cost of \$14,700. Therefore, the material and labor estimated construction cost would be \$27,200.	\$27,200.00							
First Level Public Unisex Toilet Room

Photo CL3 – Measured running slope of 8.5% on ramp.

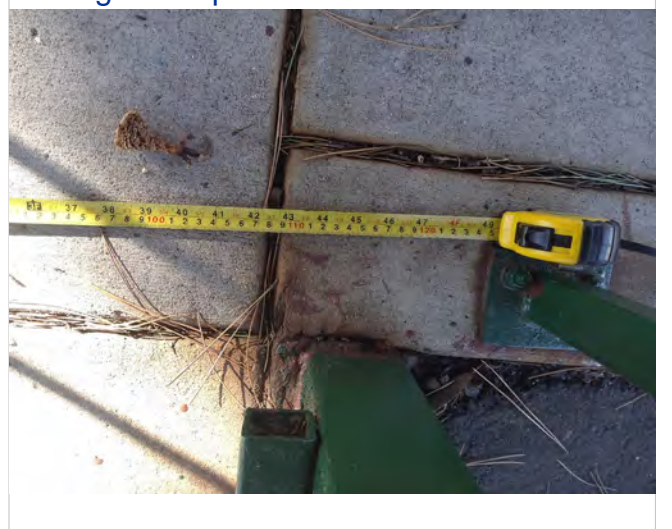
Photo CL4 – Measured width of 43” at bottom landing of ramp.

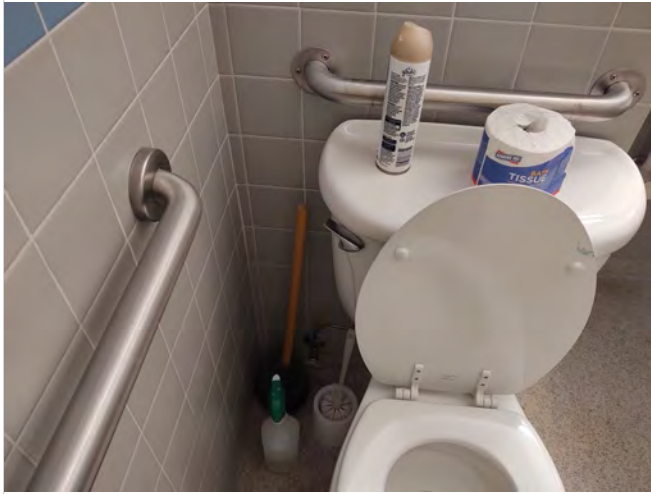
4.16.5	Water Closets - Flush Controls	Controls for flush valves shall be mounted on the wide side of toilet areas.	The flush control valve is located on the wall side of the water closet.	CL #5	Remove and replace water tank on the water closet with flush control on open side of water closet.	The estimated cost of a new "right hand" water tank is \$75.00. The labor to replace the water tank is approximately 1 hour for a labor cost of \$70.00. Therefore, the parts and labor estimated construction cost would be \$145.00.	\$145.00

Photo CL5 – Unisex Toilet Room – Flush control on wall side of water closet.

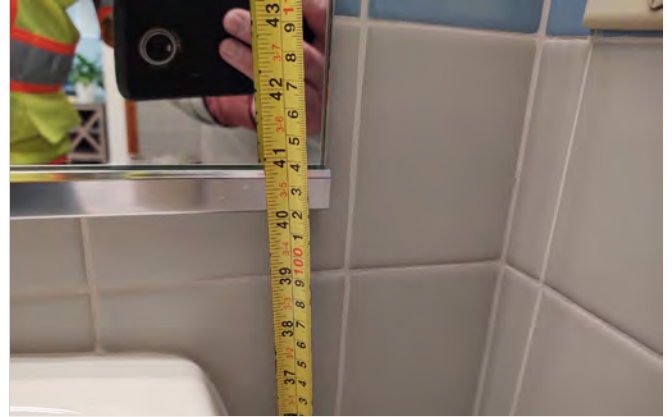
4.19.6 and 4.22.6	Mirrors	Mirrors shall be mounted with the bottom edge of the reflection surface no higher than 40" from the floor.	The bottom edge of the reflective surface is located 41" above the floor.	CL #6	The existing mirror is to be lowered to 40" above the floor.	The labor to relocate the existing mirror is approximately 1/2 hour for a labor cost of \$35.00.	\$35.00

Photo CL6 – Unisex Toilet Room – Measured height of 41” to bottom of reflective edge of mirror.

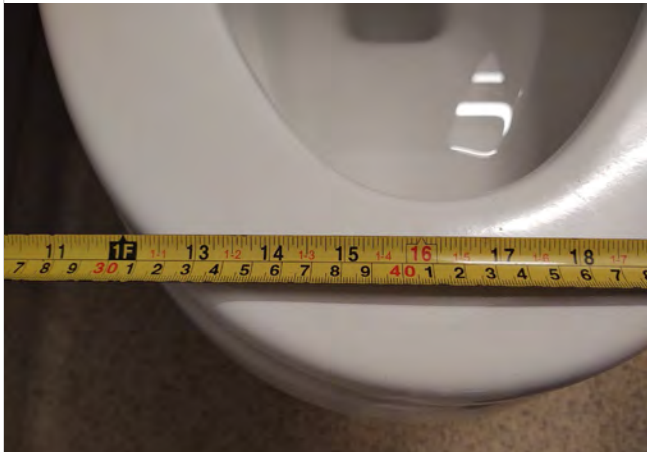
4.16.2 and Fig. 28	Clear Floor Space	The center line of the water closet is to be located between 17" and 19" from the side wall.	The center line of the water closet was measured to be 16 1/2" from the side wall.	CL #7	Remove and replace water closet so that the center line of the water closet is 18" from the side wall.	The estimated material cost to relocate the water closet is \$950.00. The labor to remove and replace the water closet is approximately 11 hour for a labor cost of \$770.00. Therefore, the parts and labor estimated construction cost would be \$950.00.	\$950.00							
First Level Kitchenette

Photo CL7 – Unisex Toilet Room – Measured dimension of 16 ½” to centerline of water closet.

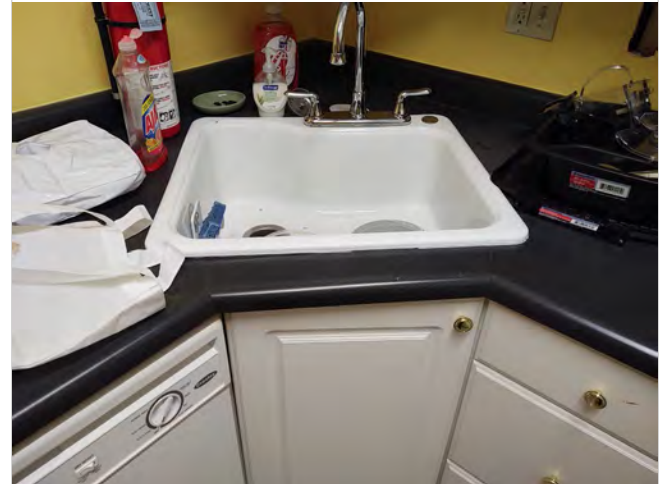
4.34.6.5(5)	Kitchen Sink	The base cabinet, if provided, shall be removable and the finished floor shall extend under the counter to the wall.	The base cabinet, if provided, shall be removable and the finished floor shall extend under the counter to the wall.	CL #8	The base cabinet is to be removed and the finished floor constructed to the back wall.	The estimated material cost to finish the bottom and edges of the sink and extend the finish flooring to the wall is \$125.00. The labor to remove the existing base cabinet and install new cabinet siding and flooring is 8 hours for a labor cost of \$560.00. Therefore, the material and labor estimated construction cost would be \$685.00.	\$685.00

Photo CL8 – Kitchenette – Kitchen sink with permanent base cabinet.

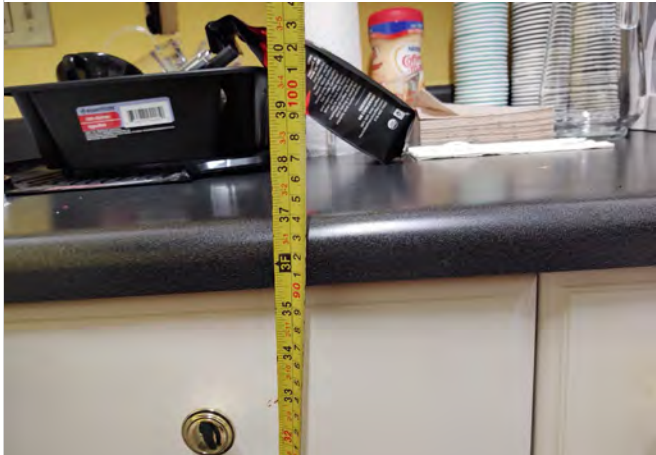
4.34.6.5(1) and Fig. 51	Kitchen Sink	The sink and surrounding counter shall be mounted at a maximum height of 34" above the floor.	The measured distance to the top of the sink is 37".	CL #9	The top of the sink and the surrounding counters are to be lowered to be not more than 34" above the floor.	The labor to lower the sink is included in item 4.34.6.5(5) above.	\$0.00

Photo CL9 – Kitchenette – Measured height of 37” to top of kitchen sink.
