CORRECTIVE ACTION PLAN

With TRANSITION PLAN

615 Main Street

Longmont, CO 80501

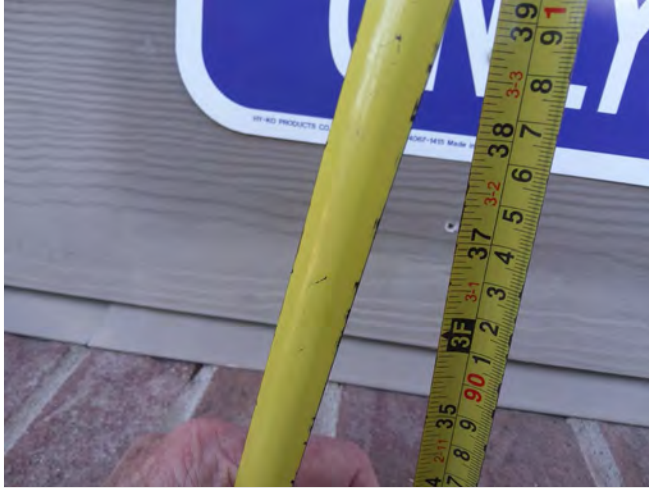
Photo CS1 – Measured height of 37 ½” to bottom of accessible sign.

4.6.4 and 4.1.1(7)(a)	Parking - Signage and Accessible Sites	Accessible parking spaces shall be designated as reserved by a sign.	The signage in front of the (2) existing accessible parking spaces are located less than 60" above the ground.		The (2) existing signs are to be relocated a minimum of 60" above the ground.	The estimated labor to relocate the (2) signs is approximately 1/2 hour per sign for a labor cost of \$70.00.	\$70.00

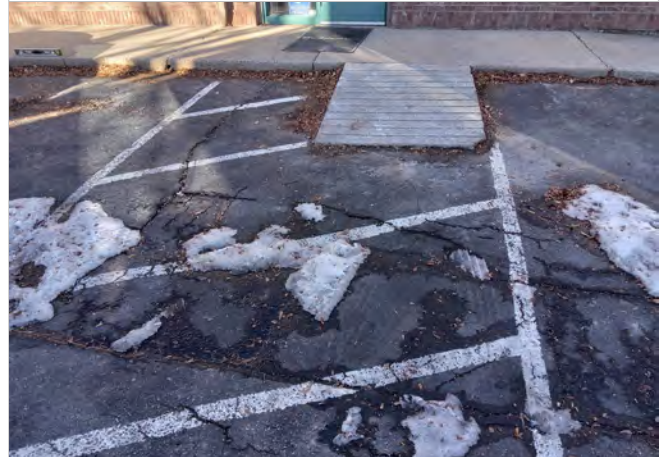
Photo CS2 – Curb ramp extending into the access aisle between accessible parking spaces.

4.7.1 and 4.7.8	Curb Ramp- Location and Obstructions	Curb ramps shall be located or protected to prevent their obstruction by parked vehicles.	The curb ramp is constructed in the access aisle.	CS #1	Remove and replace the existing concrete curb ramp.	The estimated material cost to install a new curb ramp is \$850.00. The labor to remove the existing curb ramp and install a new curb cut is 8 hours for a labor cost of \$560.00. Therefore, the material and labor estimated construction cost would be \$1,410.00.	\$1,410.00	\$1,410.00						
First Level Public Unisex Toilet Room

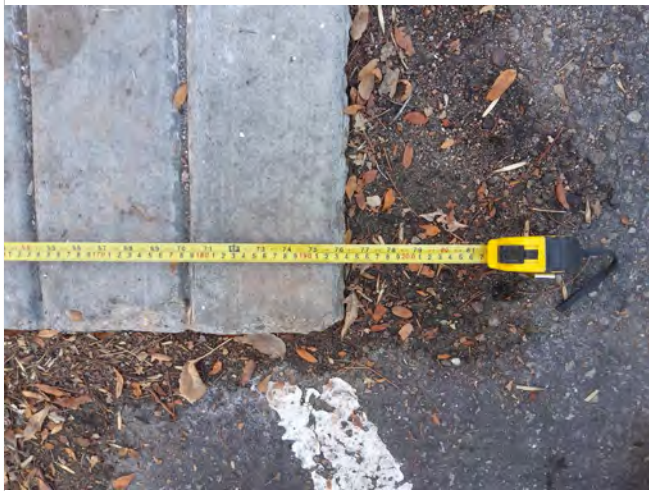
Photo CS3 – The curb ramp extends 76” into the access aisle.

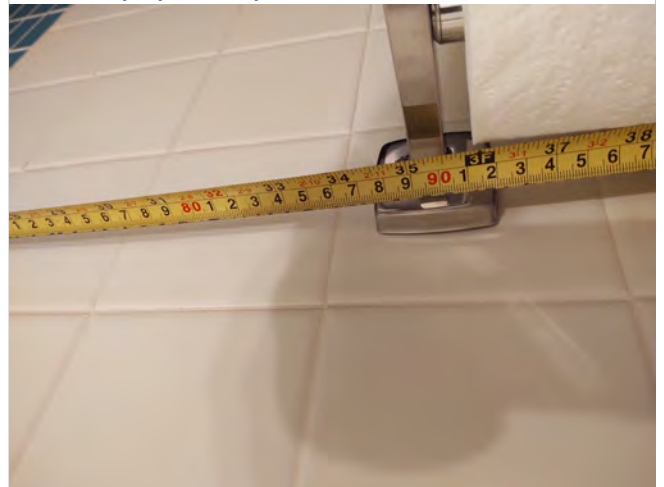
Photo CS4 – Unisex Toilet Room – Measured dimension of 35” to nearest edge of toilet paper dispenser to back wall.

4.16.6 and Fig. 29(a)	Water Closets - Dispensers	Toilet paper dispenser shall be installed within reach at 36" maximum from back wall.	The reach of the toilet paper dispenser is approximately 40" from the back wall.	CS #4	Relocate the toilet paper dispenser to be within 36" from back wall.	The labor to relocate the existing toilet paper dispenser is approximately 2 hours for a labor cost of \$150.00.	\$150.00

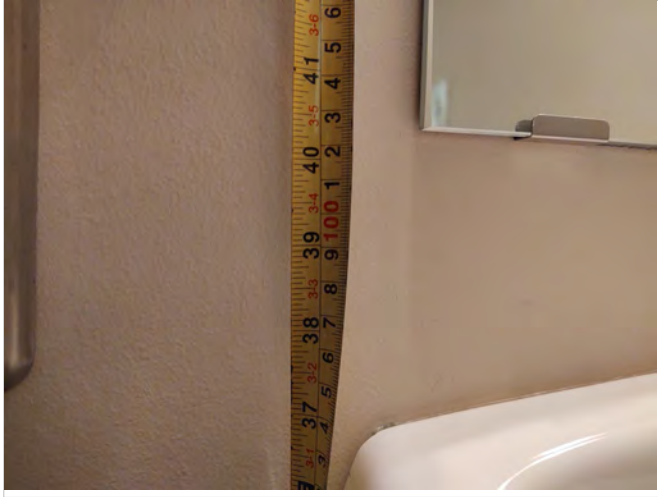
Photo CS5 – Unisex Toilet Room – Measured height of 40 ½” to bottom of reflective edge of mirror.

4.19.6 and 4.22.6	Mirrors	Mirrors shall be mounted with the bottom edge of the reflection surface no higher than 40" from the floor	The bottom edge of the reflective surface is located 40 1/2" above the floor.	CS #5	The existing mirror is to be lowered to 40" above the floor.	The labor to relocate the existing mirror is approximately 1/2 hour for a labor cost of \$35.00.	\$35.00							
TOTAL							\$1,665.00	\$1,410.00	\$0.00	\$0.00	\$0.00	\$0.00	\$0.00	\$0.00
